Cowes Yacht Club Erosion Management Options Study

Reference:
R.A10482.001.00.Cowes_Yacht_Club_Erosion_Options.docx
Date: June 2022
Confidential

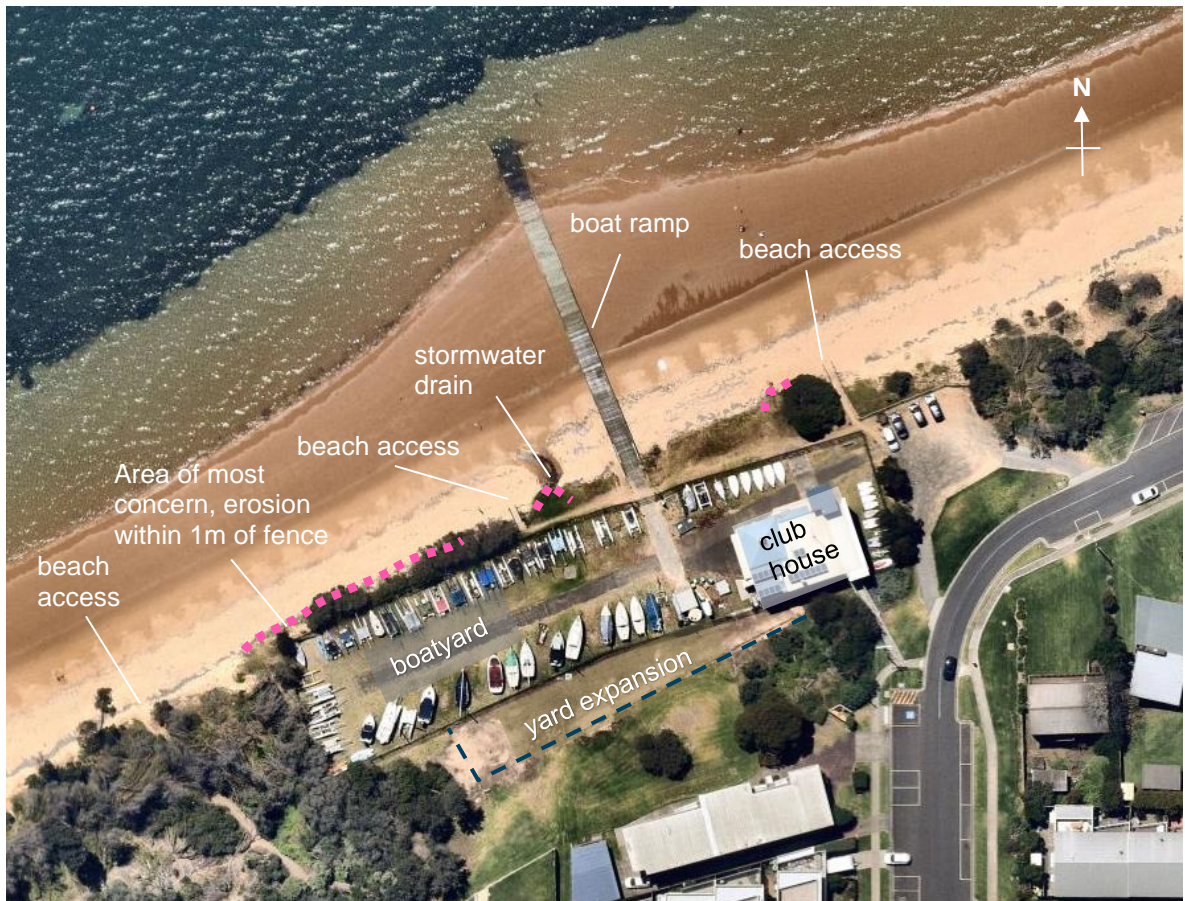
Figure 2-1 Cowes Yacht Club Site Plan (19 Nov 2020).

Rock rubble is visible at the toe of the dune seaward of approximately half the CYC frontage (pink dotted line in Figure 2-1), which is understood to have been placed pre-1970 to form an informal¹ revetment to limit erosion (pers. com. CYC). The rubble is mainly basalt, ranging in mass from less than 1 kg to more than 100kg. This structure is in very poor condition and is only providing limited protection from erosion. The rock appears to be highly fractured and is breaking down into smaller pieces. The rock seems to be undersized and as a result it has been moved and scattered onto the beach by wave action, lowering the original crest level. Erosion above and behind the rubble is most likely due to wave overtopping.

Based on review of aerial photos, it seems that the combined impact of these factors means that beach at CYC is often slightly wider, and sometimes lower, than surrounding areas (refer Figure 2-1).

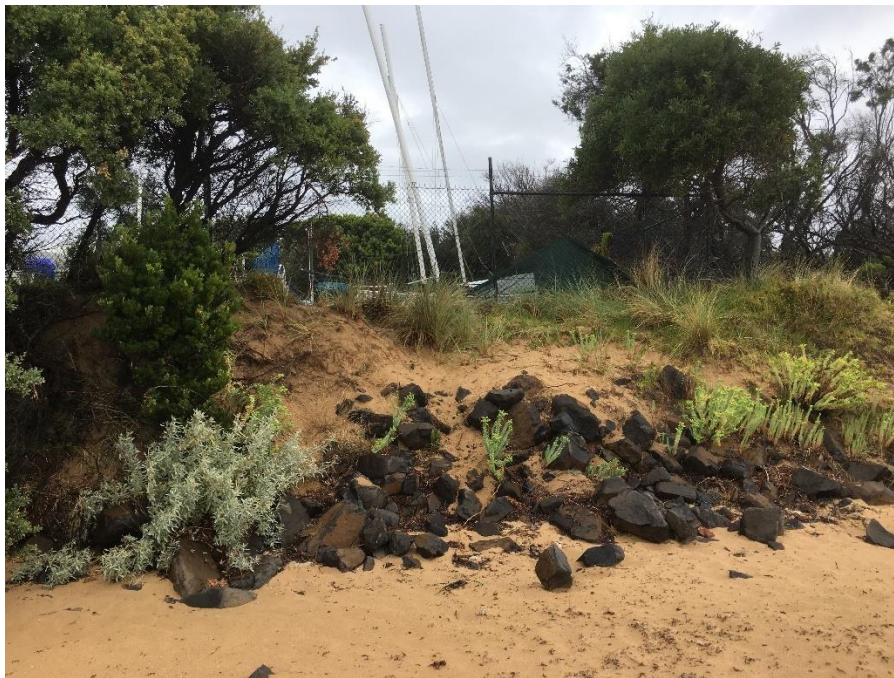
The area of most concern to the Club is the north-west corner of the yard where the erosion escarpment in the dune at the back of the beach is within approximately 1m of the fence.

Figure 2-2 North-west corner of yard, looking south, showing erosion escarpment and informal rock protection (29 Jan 2021)

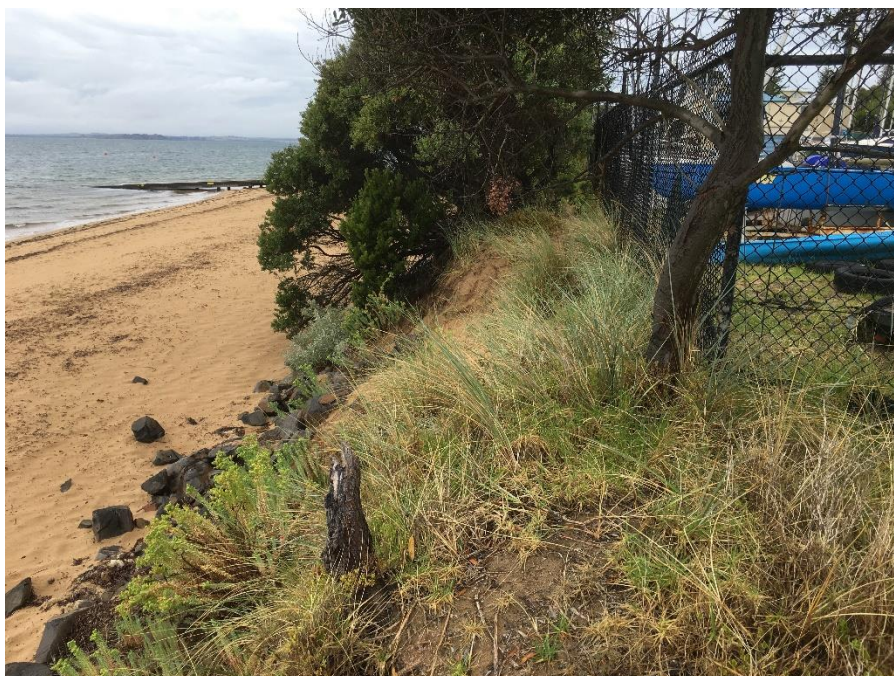
Figure 2-3 North-west corner of yard, looking east (29 Jan 2021)

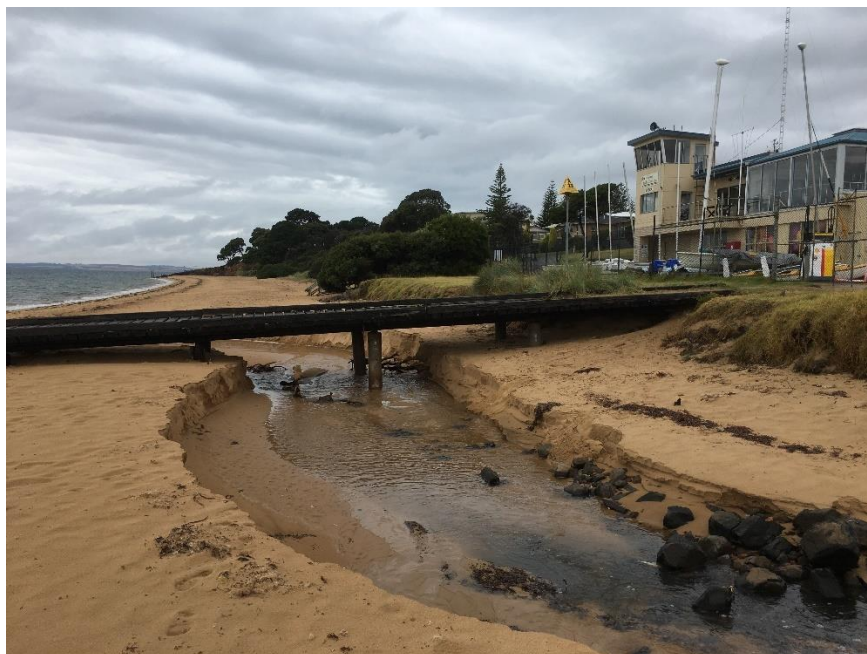
- Rubble revetments can cause scour of the beach in front of the revetment and increased erosion at either end (end scour) during storms. The informal revetment at CYC is such poor condition that its impact on coastal processes is expected to be minor, but it has not been monitored during a storm.
- Flows from the stormwater outlet move large volumes of sand off the beach rapidly during rainfall events (refer Figure 2-9). This sand is deposited in shallow water at the waterline and may be worked back onto the beach by wave action.
- The timber boat ramp can act as a 'groyne', partially blocking the along-shore transport of sand and trapping sand on the up-drift side (typically the west side, but can occur on the east as well).

Figure 2-9 Beach scour by stormwater flow 29 Jan 2021.

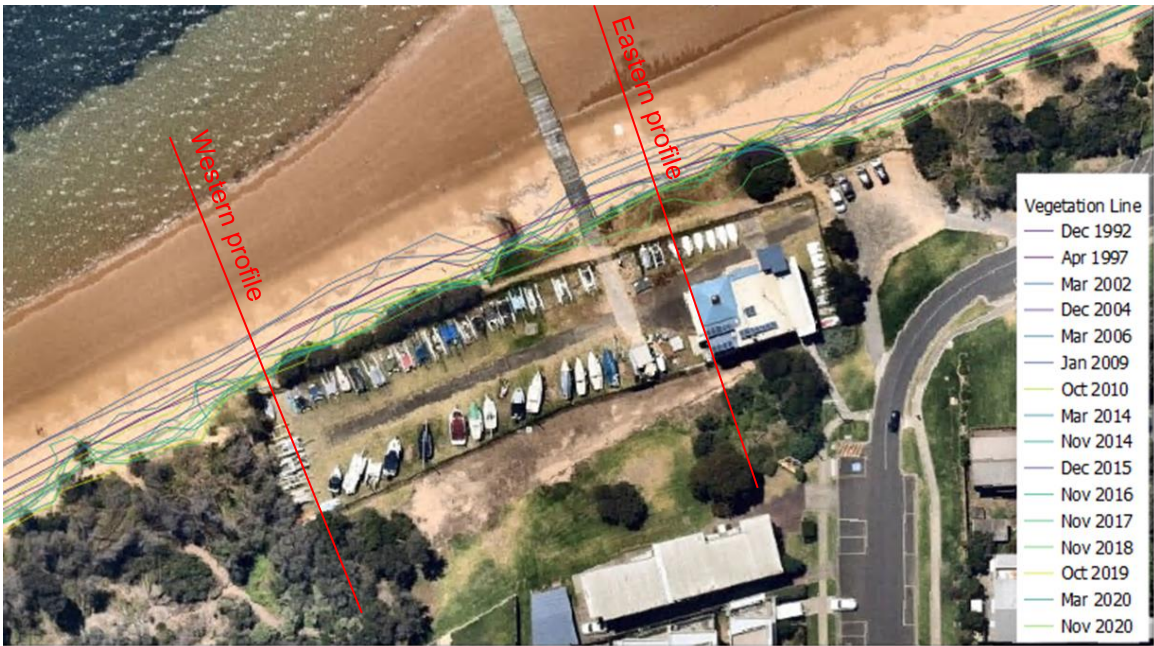
Figure 2-10 Vegetation lines from 1992 to 2020

Figure 2-10 shows the position of the vegetation line (seaward edge of vegetation) in 16 aerial photos from 1992 to 2020. This provides a good indication of the advance and retreat of the dune system and the location of the erosion escarpment, when present. The position of the vegetation line on two profiles is plotted over time in Figure 2-11.

The air photo analysis above shows that the width of the dune buffer between the CYC yard beach fluctuates by up to 8m, but over last 6 years has been persistently low. There also appears to be an overall erosion trend (vegetation/erosion line moving closer to the yard) in the order of 0.3m/yr.

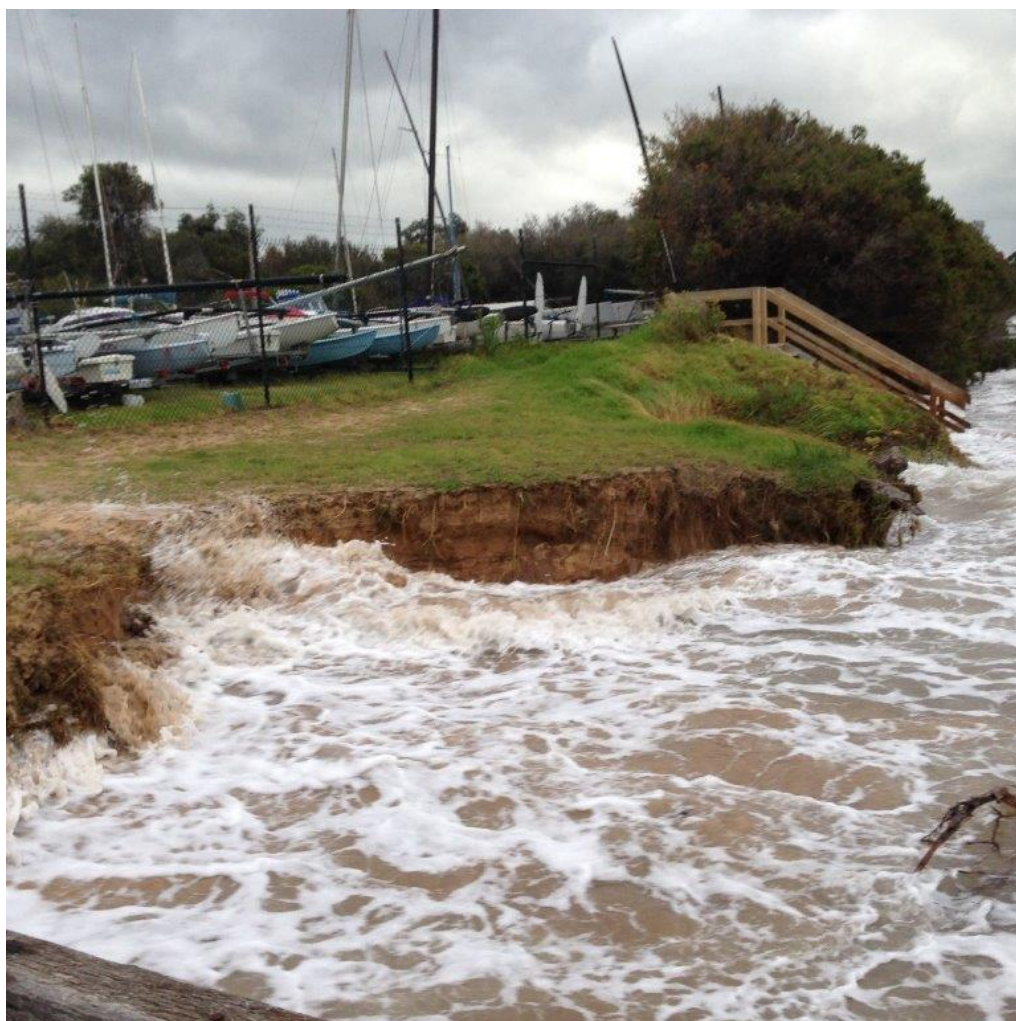
During strong northerly winds, wave set-up will elevate the water level at the shore above the storm tide level. Waves breaking on the beach under these circumstances will also 'run-up' the beach/dune face, potentially reaching a level 1 to 2 m above the storm tide level. This means there is a risk that storm waves could run up and overtop the grass/dune area at the back of the beach and run into the CYC yard, causing shallow flooding, damage to grass and scour of the soil beneath. Figure 3-1 shows that wave run-up was very close to overtopping the grassed area in front of the club in 2018. Wave runup and overtopping will become more severe with sea level rise.

Figure 3-1 Storm erosion and wave run up 2 July 2018 (photo supplied by Cowes Yacht Club)
