# Cowes East Foreshore Erosion Protection, Rose Avenue to Coghlan Road – Functional Design Report

Reference: R.M21297.001.02.docx  
Date: July 2020

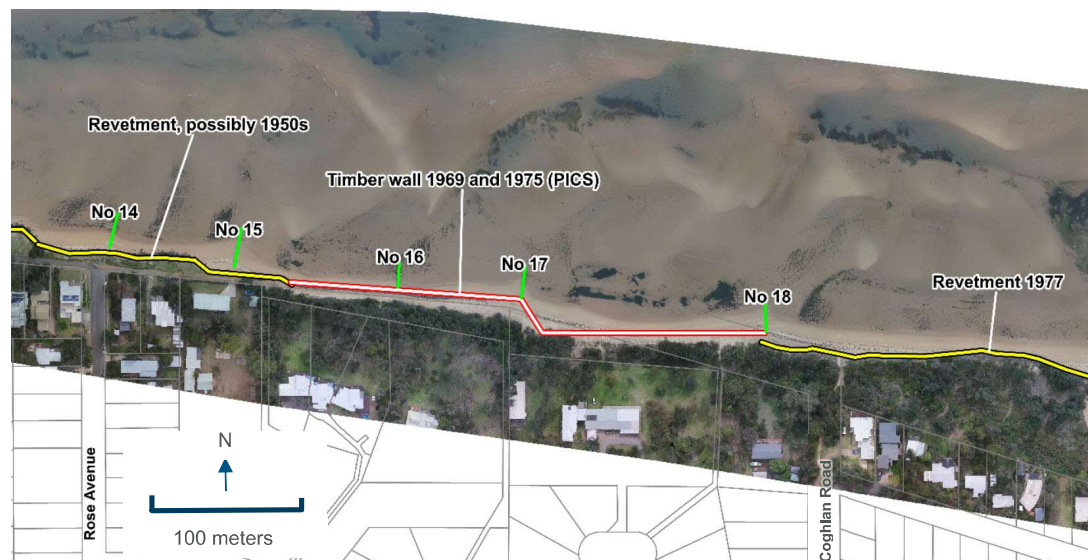
The timber seawalls and groynes in the study area (Rose Ave to Coghlan Rd) are thought to date from 1975 or earlier and are in poor to very poor condition, providing limited erosion protection.

The rock seawalls in the study area are considered to be reasonably effective although they do not meet modern design standards. Issues identified on the rock seawalls include dislodged armour rocks on the beach and a variable crest height that in places are impacted by wave overtopping. It is expected that these issues will be exacerbated by sea level rise.

Figure 4-1 Existing structures in study area

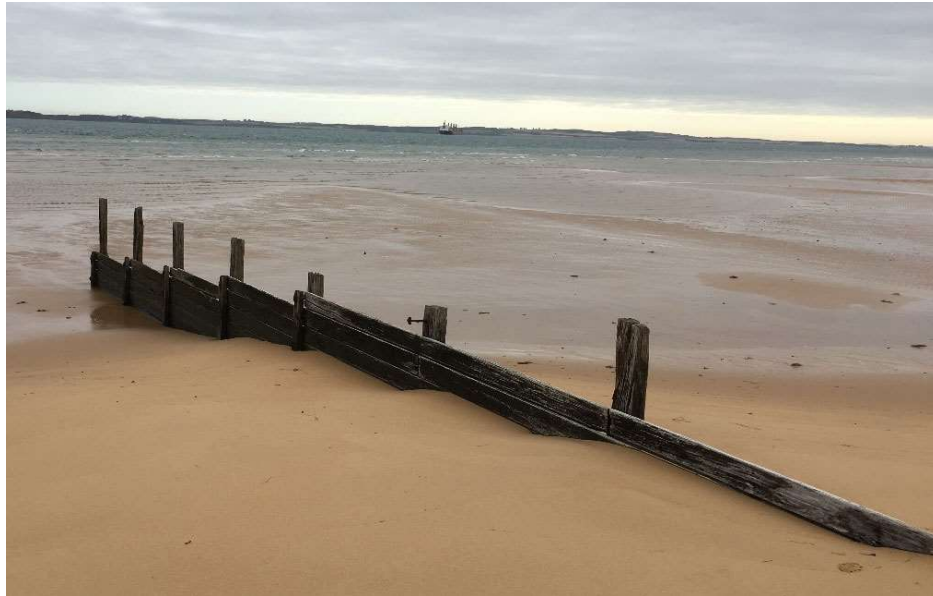
Figure 4-2 Groyne No 14 at Rose Ave. Condition is poor but it is still partially effective

- (6) **Repair timber groynes** – numbers 14 and 15 at Rose Ave and Scotch College. Replace missing panels to improve the performance of these groynes.

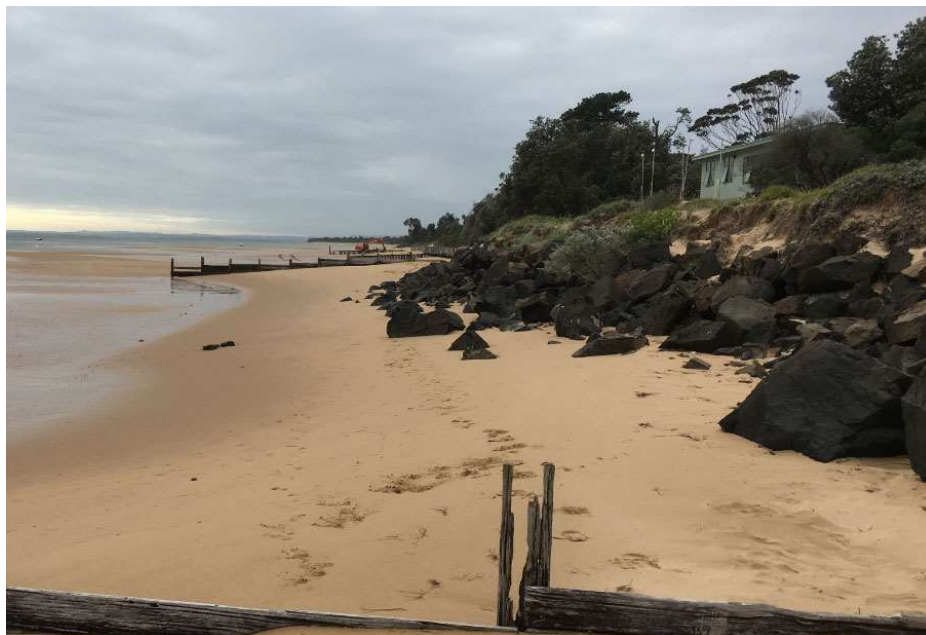
Figure 4-3 Rock wall looking east from Rose Ave, condition fair and reasonably effective

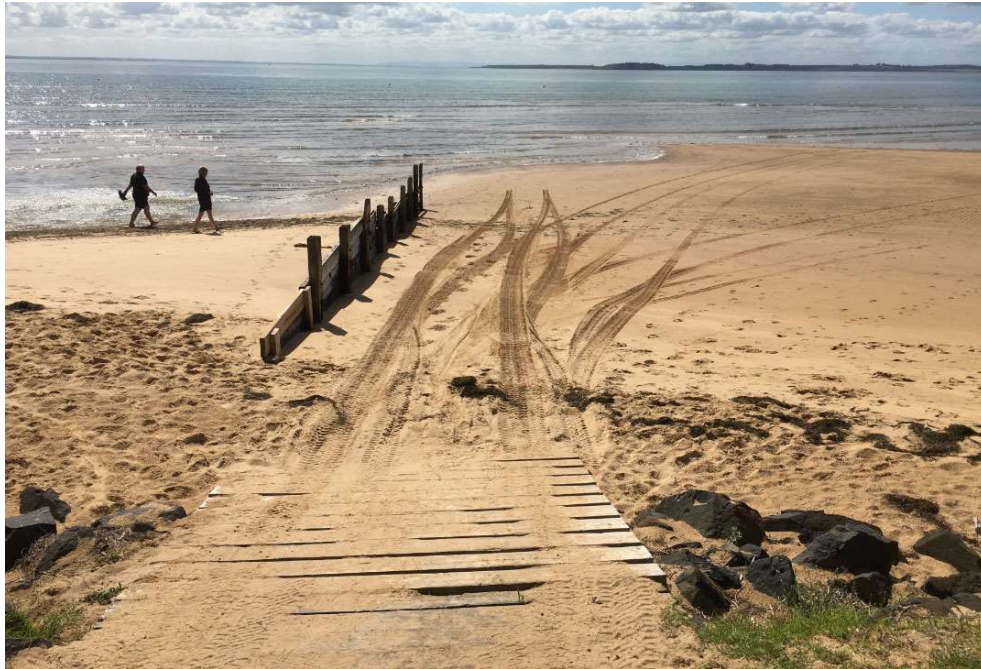
**Figure 4-4 Groyne No 15 west of Rose Ave and the Scotch College ramp. The Groyne is in poor condition but still partially effective**

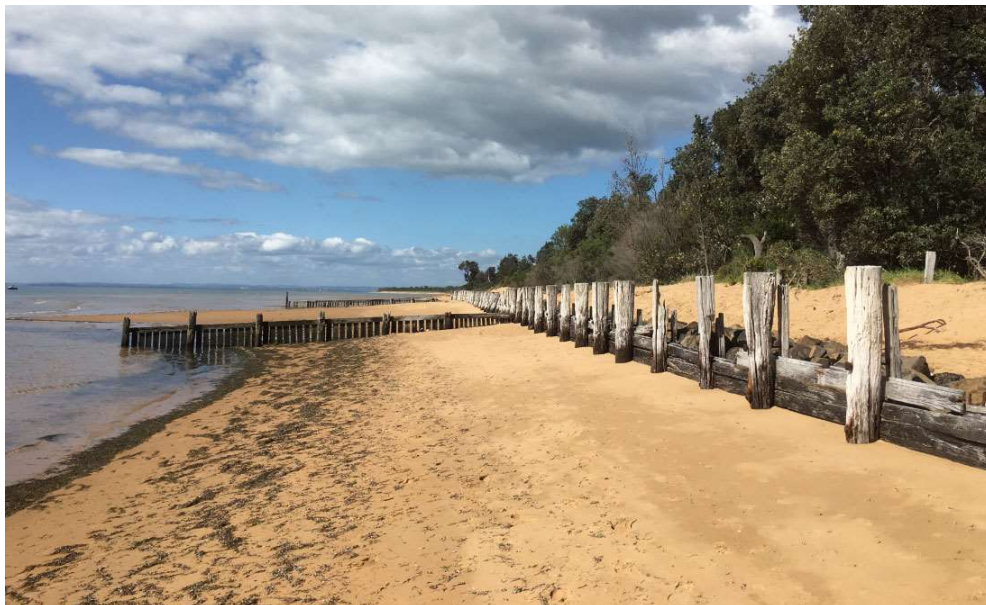
**Figure 4-5 Groyne No 16 and 17, and timber seawall, all in very poor condition and of very limited effectiveness**

- (1) **Remove existing timber groynes** – numbers 16, 17 and 18. These groynes are ineffective and deteriorating to the point where they could present a hazard to beach users.

- (2) **Remove existing timber seawall** – wall is ineffective and deteriorating to the point where it could present a hazard to beach users. Rock rubble behind the wall may be suitable for reuse in the revetment.

- (3) **Construct new rock revetment** – to replace timber seawall, approximately 330m, tied into existing rock walls at either end. Provide pedestrian access over revetment to align with existing beach access points.

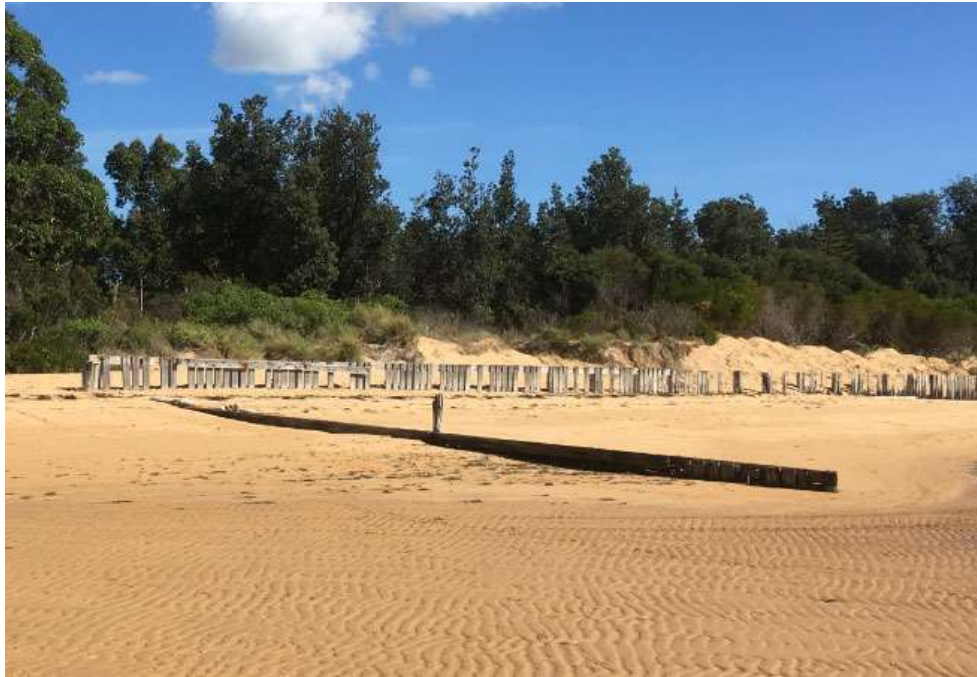
**Figure 4-6 Groyne No 18 and eastern end of timber seawall, both are in very poor condition and providing very little erosion protection**

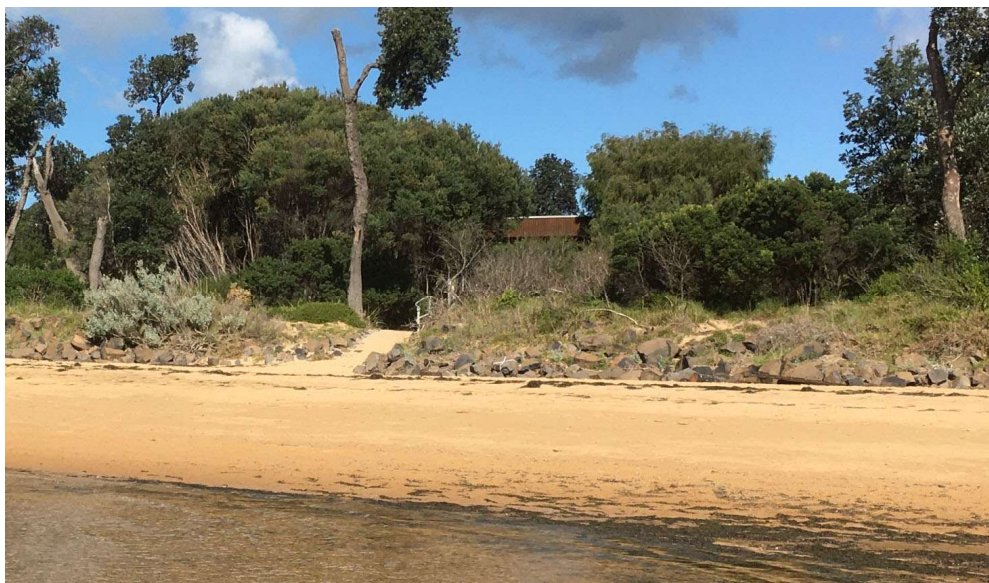
**Figure 4-7 Rock wall and pedestrian access path at Coghlan Rd. Condition of this section of rock wall is fair and reasonably effective**

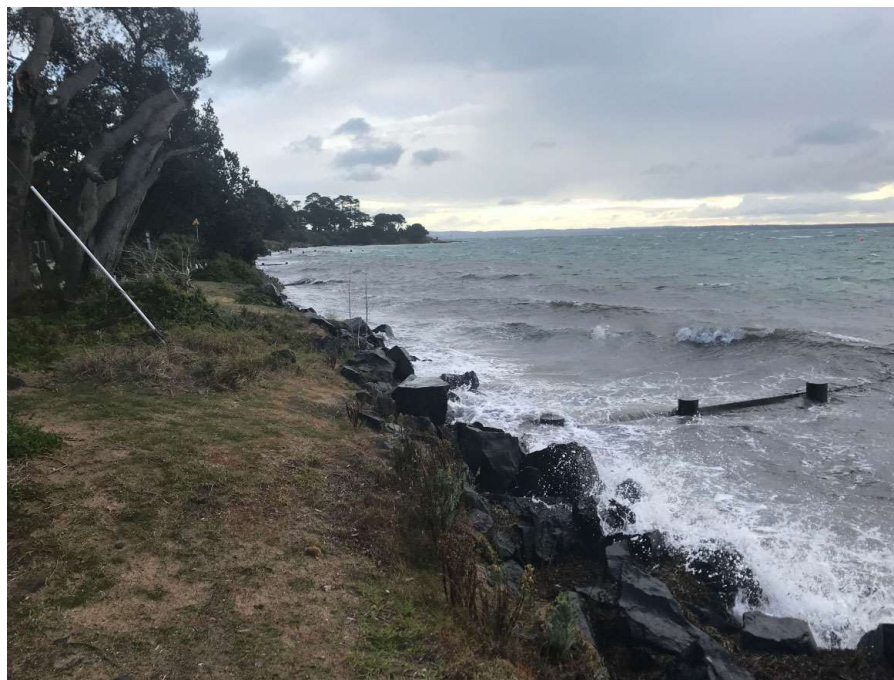
During storm events the beach can be rapidly lowered as sand is eroded and moved offshore, thereby reducing the protection afforded by the beach. Figure 5-5 shows waves directly impacting the rock seawall at Dunsmore Rd during a storm in June 2018. The top of the new groynes are just visible, indicating the water level is approximately 1.6m AHD, and no beach is visible. There are anecdotal reports of this occurring several times since 2018.

**Conclusion:** The beach formed by the new groynes provides only limited protection to the foreshore during minor erosion events. During major erosion events (occurring once or twice per year) the beach is eroded and no protection is provided.

Figure 5-5 Waves impacting rock wall at high tide 15/6/2018. Looking west from Dunsmore Rd over new groynes numbers 9, 7 and 5 (Photo from CEFPA)

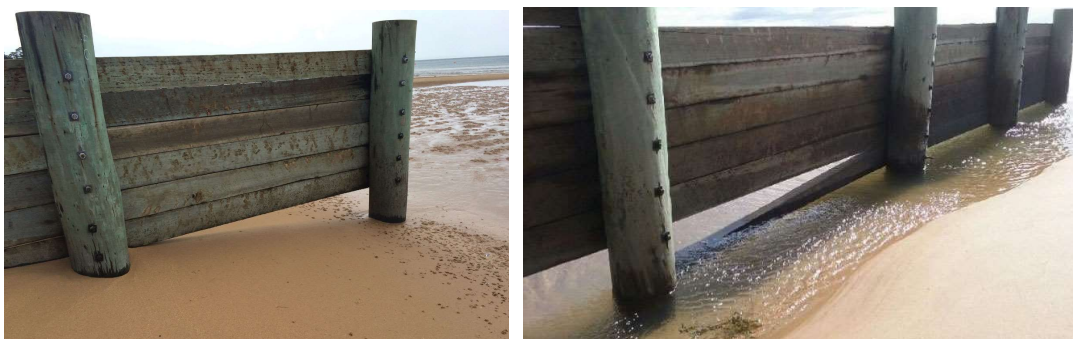
The toe levels however may be too high. The toe of the beach face can be as low as -0.5m AHD where it intersects a trough on the surface of Cowes Bank. If gaps exist or form in segments underneath the toe of the groyne (for example as shown in Figure 5-8) then the groyne is not as effective at trapping sand.

Figure 5-8 Gaps under new groyne no. 13 (photo from CEFPA, precise date not known)

To maintain the effectiveness of the groynes it is necessary to replace any panels that are dislodged. A gap underneath will hamper sand capture and a gap on top will reduce the height of the formed beach.
