Kilcunda Foreshore Erosion: Options Assessment

BMT Commercial Australia Pty Ltd	Document:	R.A10950.01.02.Kilcunda_Foreshore_Ero sion_Options_Assessment_FINAL.docx
Level 5, 99 King Street Melbourne Vic 3000 Australia	Title:	Kilcunda Foreshore Erosion: Options Assessment
Tel: +61 3 8620 6100	Project Manager:	Christian Taylor
ABN 54 010 830 421	Author:	Taylor Rubinstein
www.bmt.org	Client:	Bass Coast Shire Council
	Client Contact:	Derek Hibbert
	Client Reference:	
Synopsis:

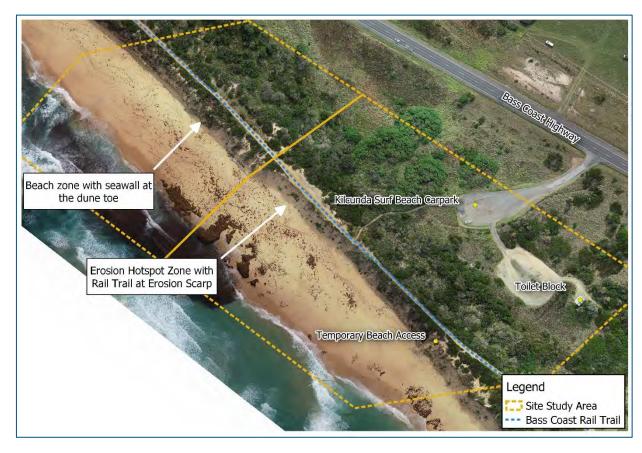
Figure 1 Site Map

Erosion occurring at the end of an existing historic seawall structure on the beach has severely impacted the dunes in recent years. This is demonstrated by the loss of multiple beach access stairs in the last decade from the Kilcunda Surf Beach carpark and the cemetery. In the last year, erosion has begun to impact the edge of the Bass Coast Rail Trail with some of the trail eroded off the dune edge (Figure 1).

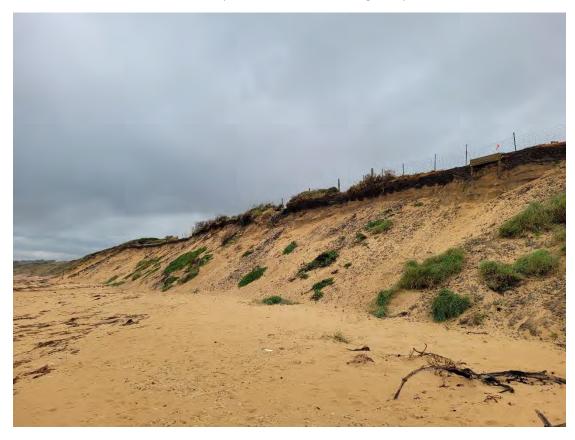
Figure 1-2 Erosion Hotspot with safety fencing on the crest.

The problem area this study focusses on is SE of the historic seawall structure (See following section and Figure 1-3) where coastal erosion has cut into the dune face creating a steep scarp destroying the beach access stairs and undermining section of the rail trail. The length of trail currently at risk from erosion is estimated at 160 m (refer Section 3.1 and Figure 2).

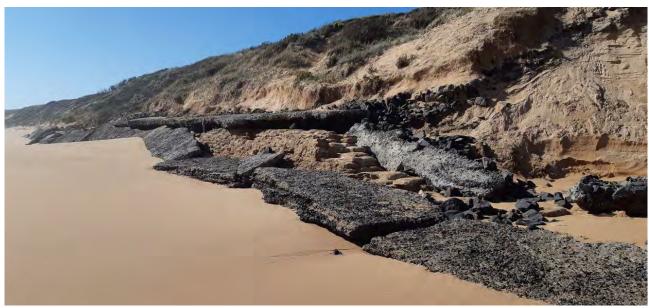
Figure 1-3 Existing Seawall Structure NW of Erosion Hotspot

As previously mentioned, the seawall is in very poor condition with significant subsidence, cracks, dislodged armour and blowouts evident along its length. As sea levels rise, increased water depth at the wall toe will cause larger waves to break on the structure causing more damage. For our estimate of current and future erosion hazard zones at the site (Section 2.3.4) we therefore assume the wall has failed and the dune will recede landward from its present position as the same rate as the unprotected area. As such, we adopt a recession rate due to sediment loss of 0.3 m/year for both beach zones for further calculations (Table 2-10).

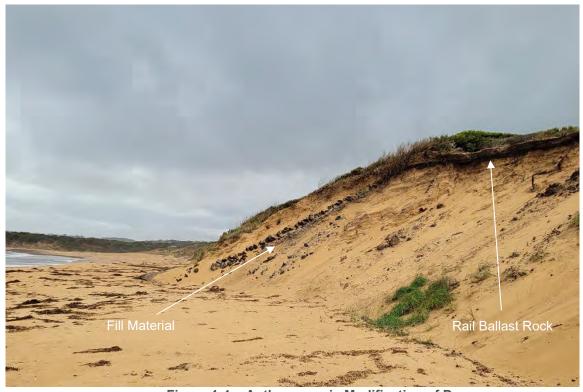
Figure 1-4 Anthropogenic Modification of Dune

The timeframe of construction of these coastal modifications is uncertain, however, it is theorised to have been during the rail line era, (1910 - 1978).

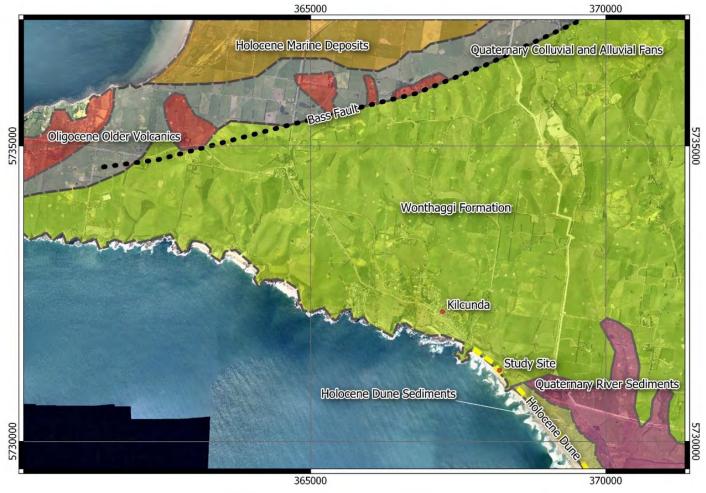
Figure 2-1 Geomorphology Map (Adapted from GeoVic)

During the Holocene Still Stand with sea levels fairly constant for the last 6,000 years, dune barriers have formed between headlands of cretaceous sediments. These can be seen at the Kilcunda Surf Beach study site, as well as further south. These are predominantly at high elevations and between Kilcunda and Cape Patterson are only dissected by the Powlett river and the Bourne Creek.

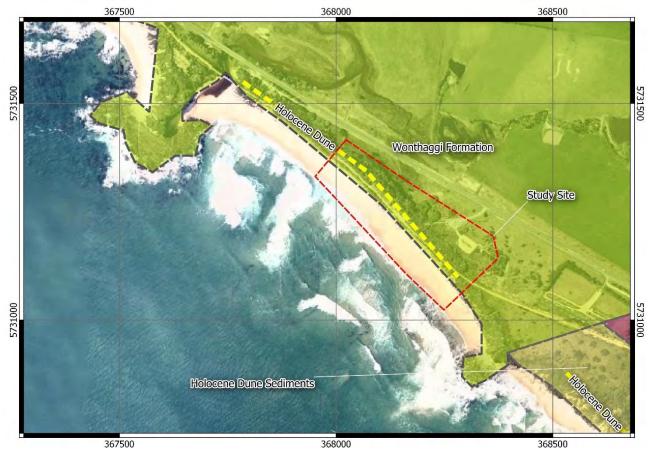
Figure 2-2 Site Specific Geomorphology

The Kilcunda Surf beach Study site is characterised by a wide and relatively steeply sloping high energy surf beach. Seaward of the shoreline, sand is worked into banks and rip-channels by incoming swell waves. The beach is bounded on the NW and SE by two headlands of the Wonthaggi formation cretaceous sediments. These create barriers to sediment moving along the shore with the larger northern headland more effective at this.

Holocene barrier dunes have formed between the headlands with the dunes dissected by the Bourne Creek ICOL entrance adjacent to the NW headland. There is no evidence that this lagoon mouth has significantly changed its configuration since 2007 with only minimal movement of the stream location.

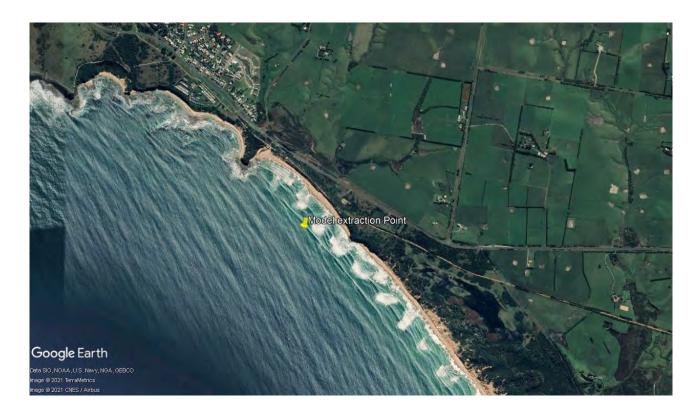
Figure 2-5 SWAN model extraction point

We used an existing BMT Bass Strait SWAN model to characterise the wave climate at Kilcunda as shown in Figure 2-5. This model incorporates swell waves entering Bass Strait from the east and west (from global wave models), wind wave generation, wave interaction, refraction and shoaling within Bass Strait. The model was used to hindcast 12 years of wave conditions and results were reported from the point between 1987 and 1999. An extreme value analysis of this data was also conducted for significant wave height to determine the magnitude of various return interval events. The model was previously calibrated using Apollo Bay wave measurements.

Note that modelled wave conditions were extracted at nearshore location, seaward of the surfzone, with a mean depth of approximately 8m. Long period swell waves will have undergone significant shoaling and refraction before they reach this point, which means that the reported waves are lower height and more shore-normal in direction than the deep water wave climate further offshore.

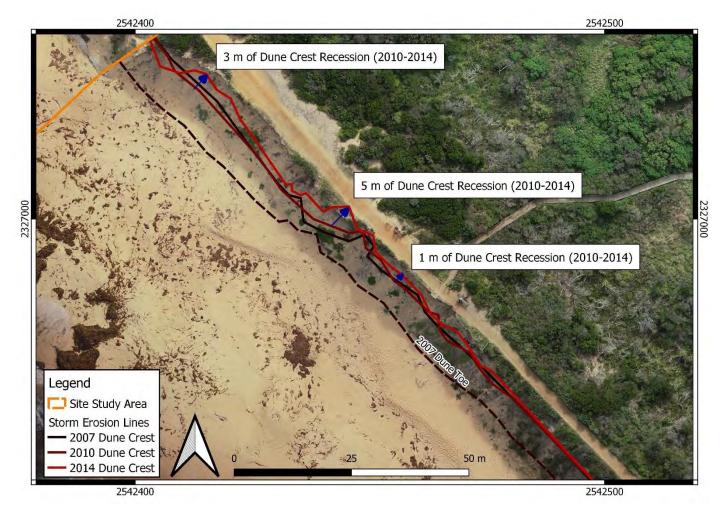
Figure 2-8 Comparison of Dune Crest Erosion 2007 – 2021.

A separate analysis of dune erosion was also undertaken via comparison of the limited aerial imagery available on Google Earth from the previous 14 years (2007 - 2021). The dune crest line (top of erosion scarp) in the erosion hotspot zone was compared visually between consecutive images to find the time period with the greatest horizontal storm recession of the dune crest.

The results of this analysis are summarized in Table 2-7 and Figure 2-8, showing the greatest horizontal erosion of the dune crest during the previous decade was seen between 2010 and 2014, up to a horizontal distance of 5 m.

As such, we nominally adopt the maximum dune crest erosion value of 5 m during the last decade (2010 - 2021) as the storm erosion potential for an ARI10 year storm.

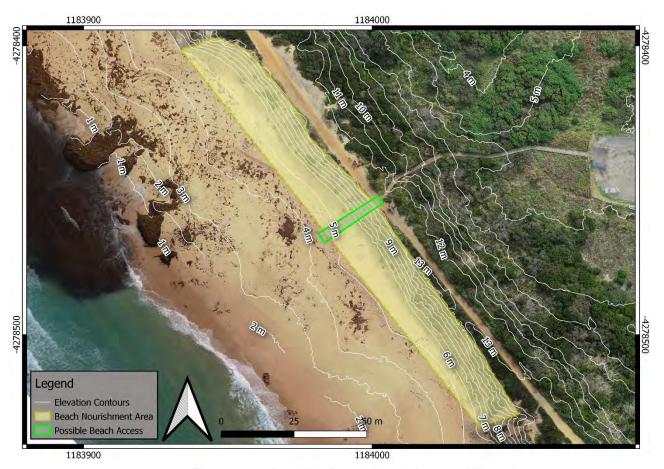
Figure 4-4 Possible Beach Nourishment - Kilcunda

Dune management, such as fencing, planting and matting, is often used to increase the stability of nourished material against wave attack. This would not likely be effective at Kilcunda due to the high wave climate (Morris et al. 2021), thus it is not suggested in this option.

- Beach/Dune Nourishment This option would nourish the beach and re-build the dune in the erosion hotspot area to protect the rail trail from erosion. Sand would ideally be taken from an on-beach borrow area. This may be considerably expensive depending on the ease of transporting sand to the site and may only be effective for weeks months due to the high wave climate. This option is not recommended for this site because of the high cost and short effective lifetime.

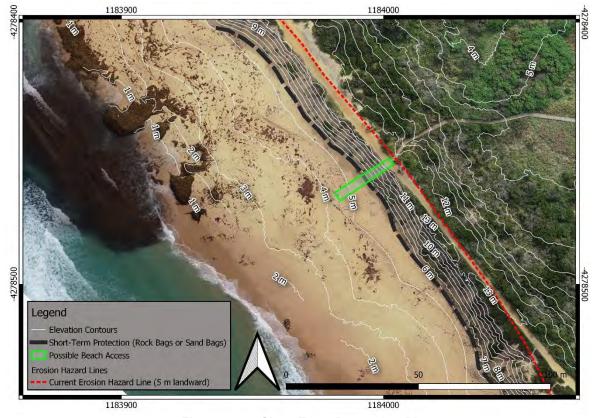
Figure 4-5 Short Term Protection Placement

Geotextile sandbags would be more favourable compared to rock bags here. Sandbags are made from woven geotextile fabric and come in 0.75 m³ and 2.5 m³ (larger bags would likely be used here due to the high wave climate). They would be filled with beach sand and then stacked in layers to construct a tired wall at the dune toe in the erosion hotspot. Sandbags can shift slightly under wave impact because of their flexibility and still maintain the structural integrity of the wall (Hornsey et al. 2011). Sandbags walls can be expensive to construct (similar to a rock revetment per m), but with correct design may last up to 10 years at Kilcunda. This option may be used in concert with retreating the Rail Trail on the dune crest to potentially increase the lifetime of that option, or it could be used while more permanent protection is designed. Beach access stairs could be constructed from the carpark over the short-term protection, depending on the desired deployment timeframe. Short-term protection would not likely lower the risk to trail users by itself due to the existing vertical erosion scarp still at risk of slumping and eroding the path.

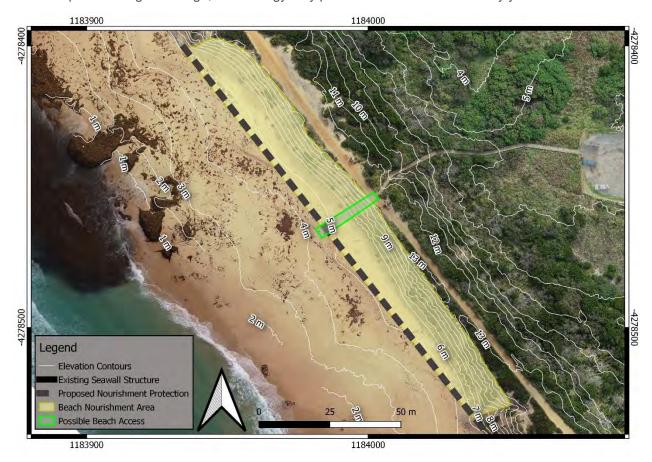
Figure 4-6 Dune Protection with Nourishment

This sort of protection strategy is designated as an 'option of last resort' in the Victorian Marine and Coastal Policy (DELWP 2020) because it is inherently expensive, may shift the erosion issue to other areas and would have considerable impact on coastal processes. It also may have negative impacts on coastal processes with lowering of the beach level in front of the revetment and end scour.

It is not likely that this option will be needed soon at Kilcunda due to the relative ease of retreating the Bass Coast Rail Trail. This option is, however, a valid way of defending the coastline from erosion and, in a future case where erosion may threaten more valuable assets, this may become the best option. With good design, this strategy may protect coastal assets for many years into the future.
