# Coastal Erosion Management Options

## Cowes Main Beach Foreshore Reserve

Bass Coastal Shire Council

April 2018

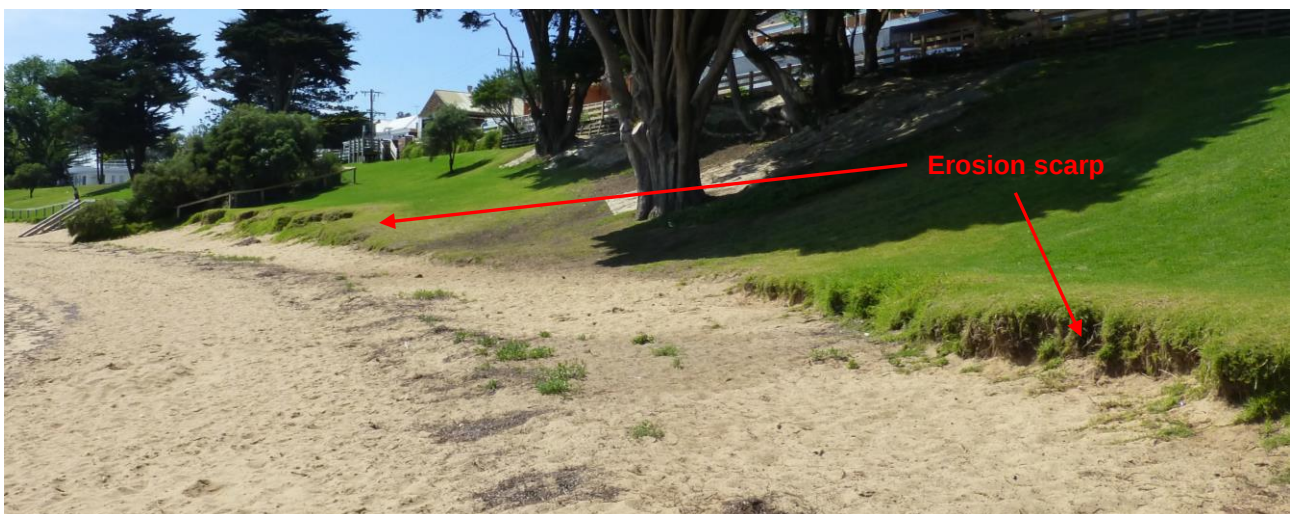
Figure 2-1 Erosion scarp at beach interface with foreshore reserve

- Erosion scarp present at the interface between the beach and the foreshore reserve (Figure 2-1 and Figure 2-2)
- Beach access points; stairs, ramp and dune (Figure 2-3)
- Rocky headlands at both ends of the beach (Figure 2-4)
- Stormwater outfalls at two locations within the beach (Figure 2-5)
- A rocky / reef substrate is present around the water line at many locations along the beach. (Figure 2-6)
- A fence is located on the larger sections of the beach scarp with the aim of directing foot traffic. (Figure 2-7)

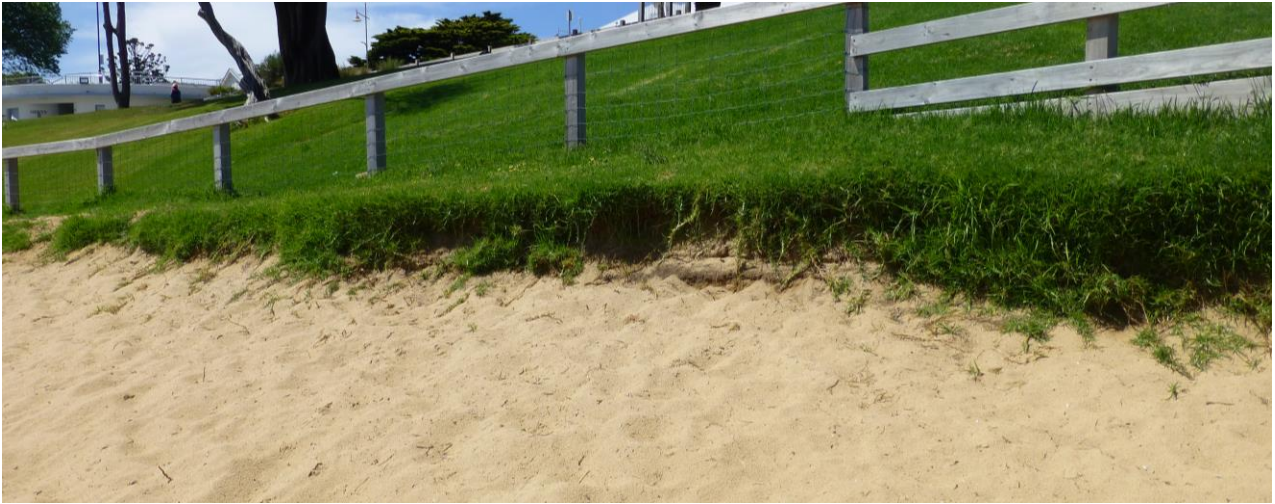
**Figure 2-2** Erosion scarp at beach interface with foreshore reserve

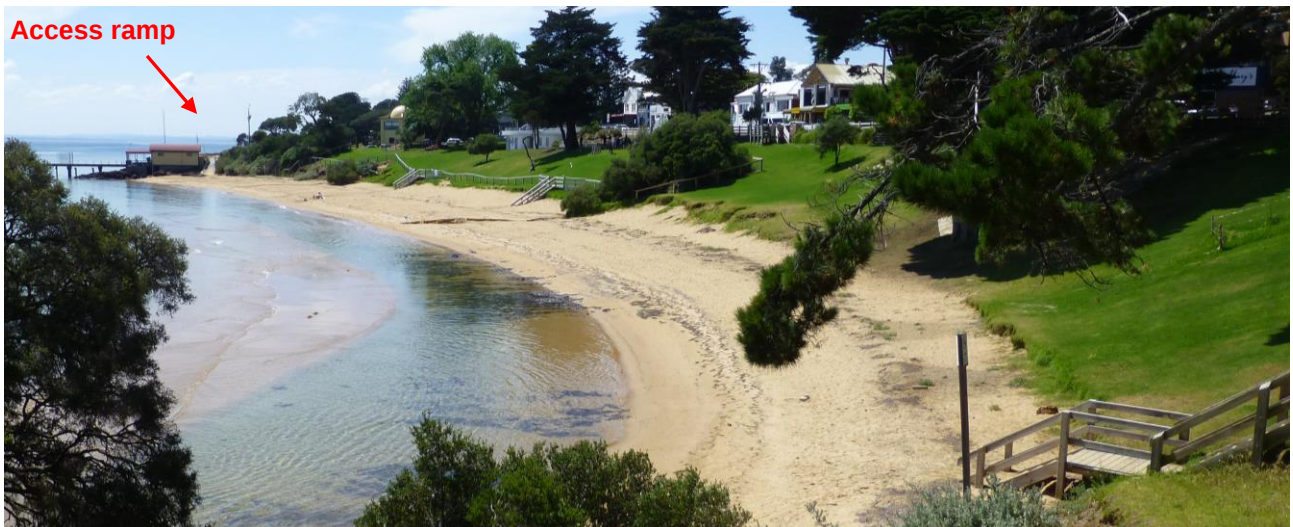
**Figure 2-3** Beach access points (stairs, dune and ramp (far end of beach))

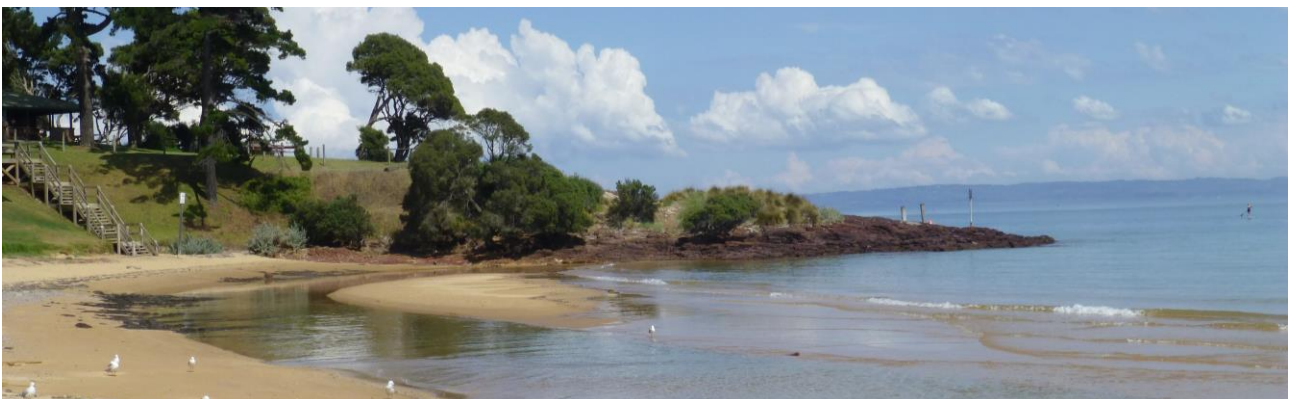
**Figure 2-4** Rocky outcrop at the western end of Cowes main beach

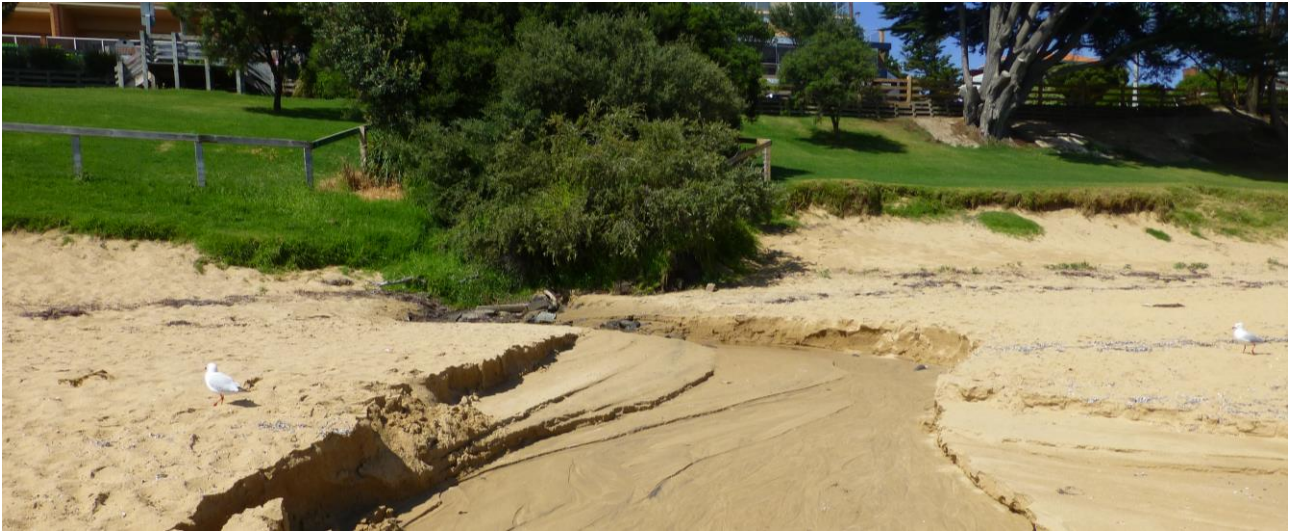
**Figure 2-5 Storm water outfall located on Cowes main beach.**

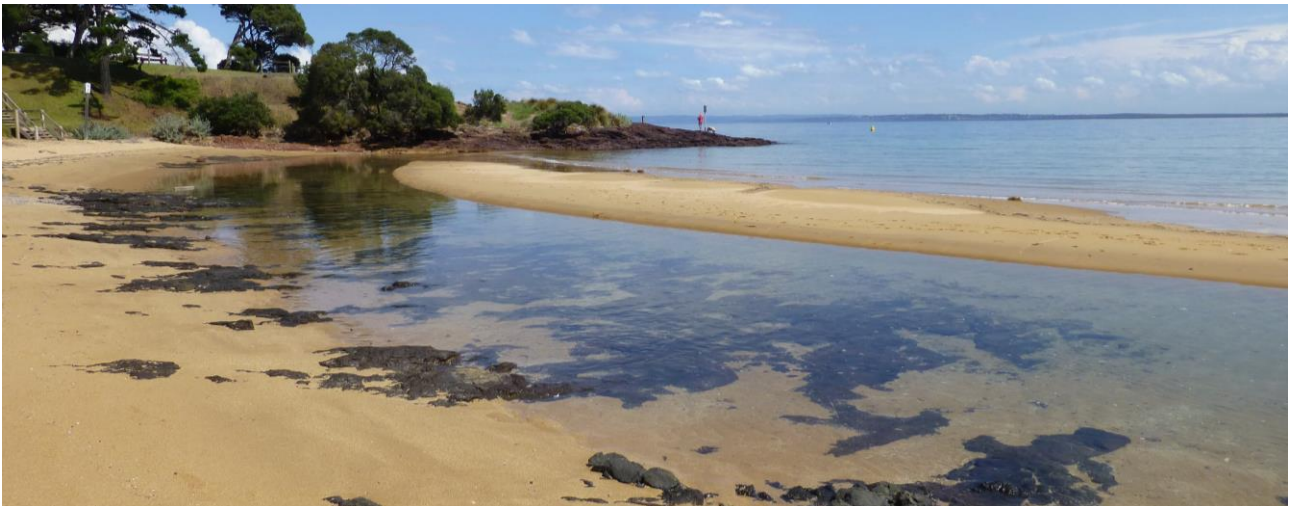
**Figure 2-6 Rocky / reef substrate on Cowes main beach.**

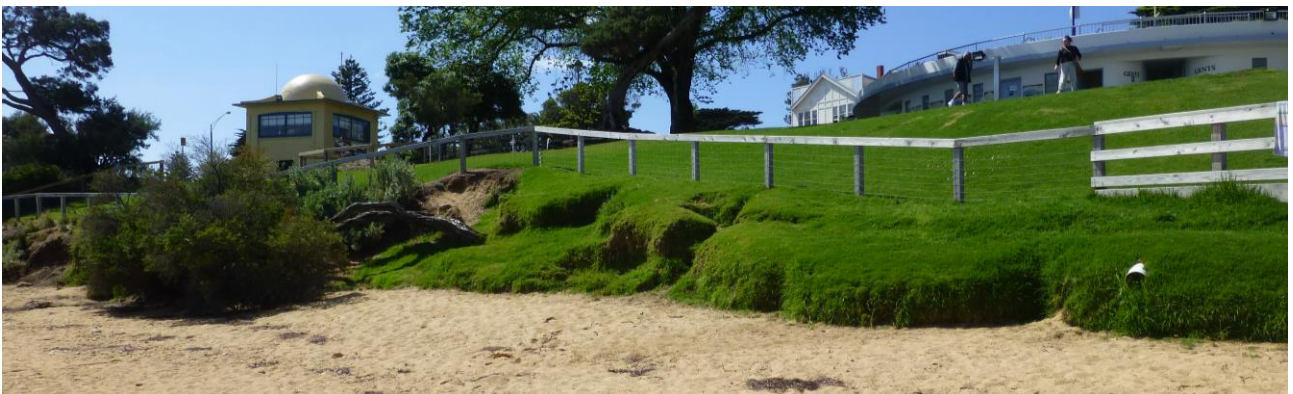
**Figure 2-7 Fence to manage foot traffic located on Cowes main beach foreshore reserve.**

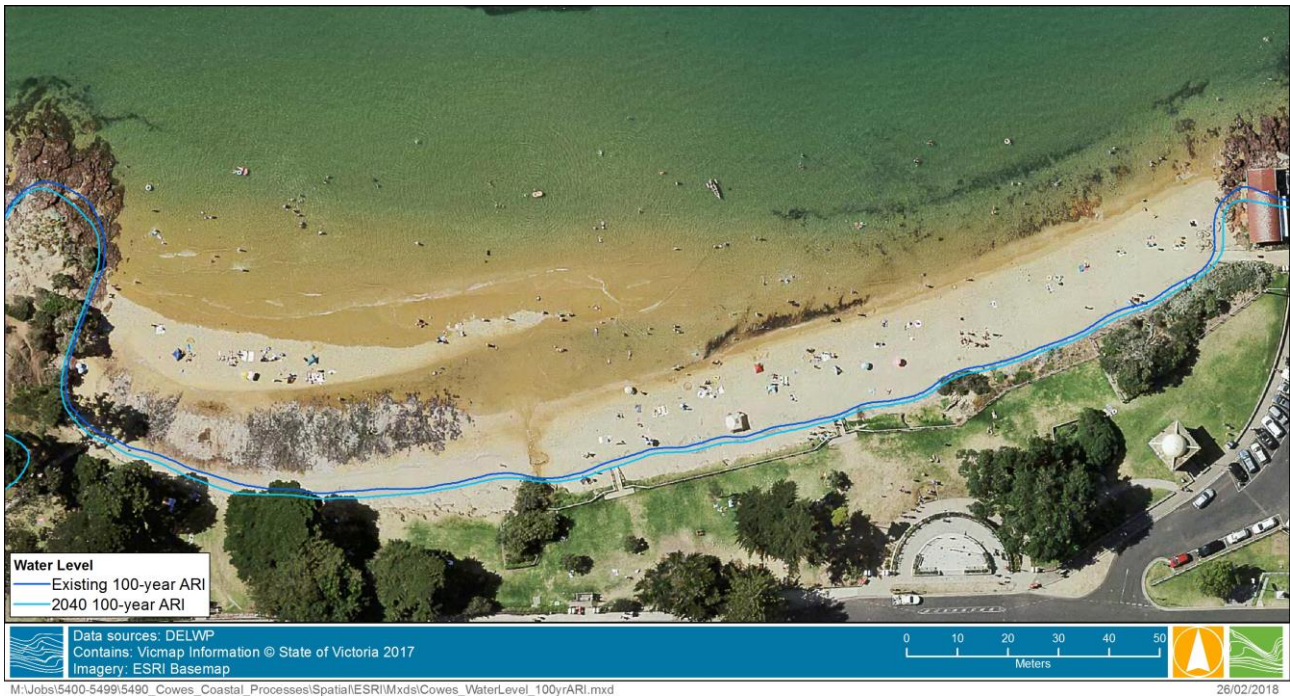
**Figure 4-2** Extent of 100-year ARI water levels on the site for present day and 2040

The 2040 climate change scenario has been utilised to predict the effects at the end of the design life, in line with the management option design life of 20-25 years. The difference between the existing and 2040 100-year ARI storm tide seen in Figure 4-2 reveals only a slight lateral migration, corresponding to the 20cm of sea level rise accommodated in the 2040 scenario. The eastern end of the beach is at a greater risk to erosion as can be seen by the close proximity of both blue lines to the foreshore reserve behind the beach face.

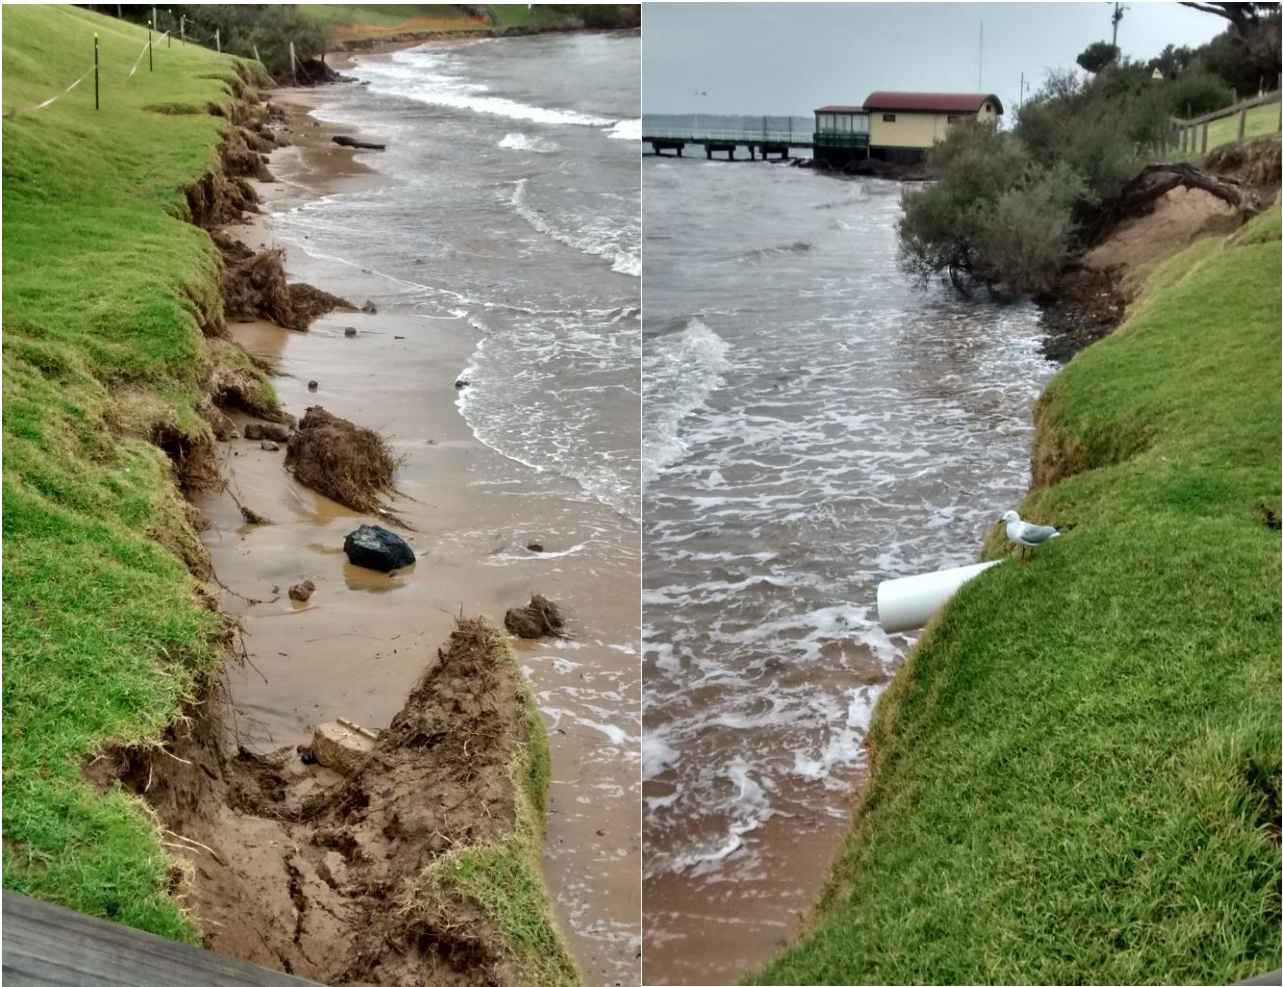
**Figure 4-5** Storm action leading to erosion, 22<sup>nd</sup> July 2016 (Bass Coast Shire Council)

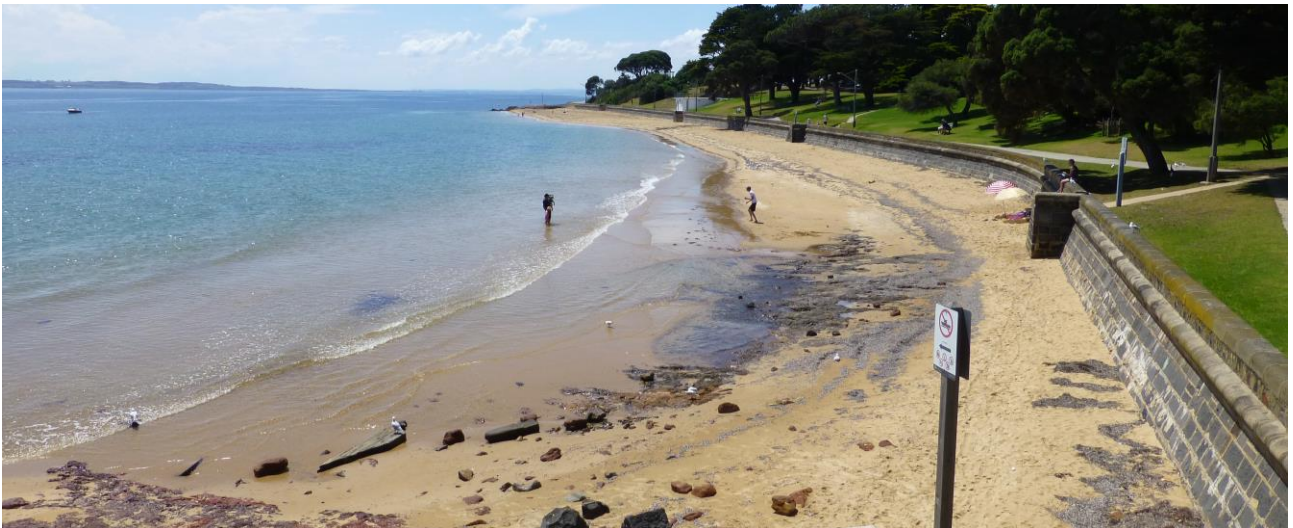
**Figure 6-2** Cowes East Beach at time of site visit – 17<sup>th</sup> November 2017

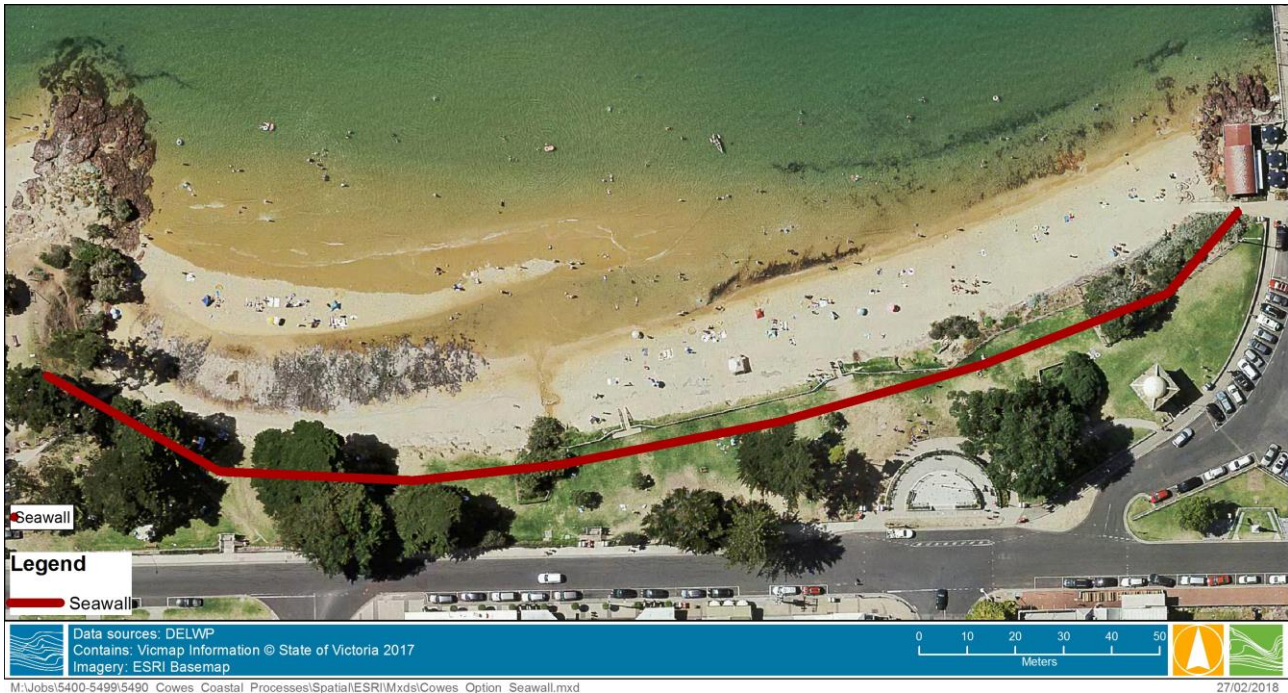
Figure 7-6 Indicative seawall location in plan view

A sketch of the indicative seawall location is provided in Figure 7-6; access points are not included.
