# Cowes East Foreshore Erosion Protection, Rose Avenue to Coghlan Road – Functional Design Report

Reference: R.M21297.001.02.docx  
Date: July 2020

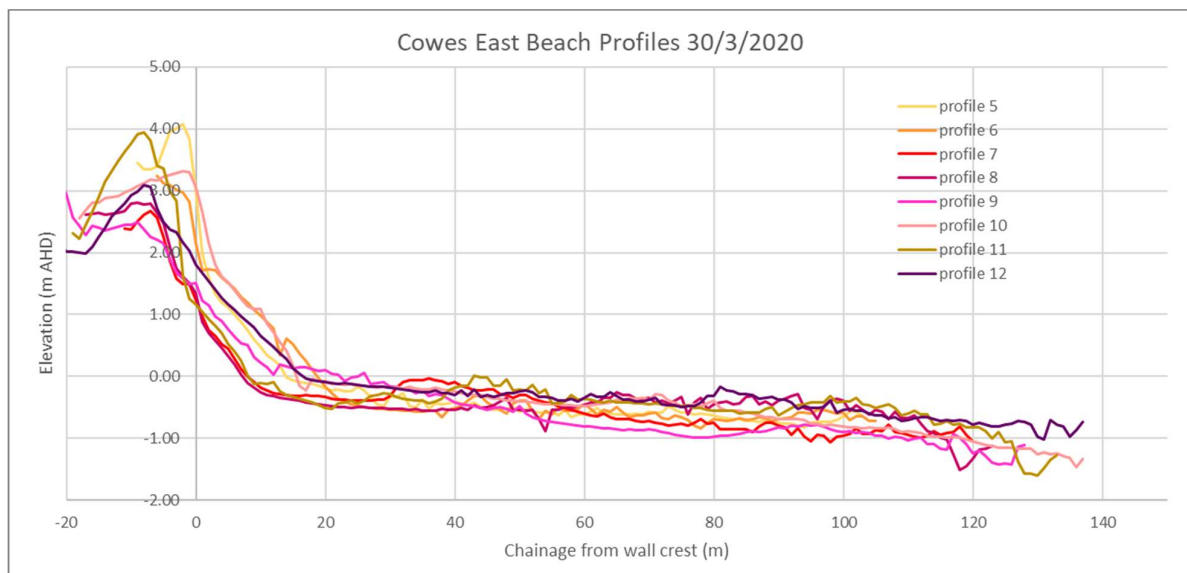
Figure 3-1 Beach Profiles in study area (approx. 50m spacing between Rose Ave and Coghlan Rd)

The beach in the study area is relatively narrow and steep, as shown in Figure 3-1. The beach face rises from approximately 0m AHD to the dune crest or rock wall crest at 2.5m to 4.0m AHD. There is no high-tide berm (flat area above high tide line) evident at the time the survey was taken.

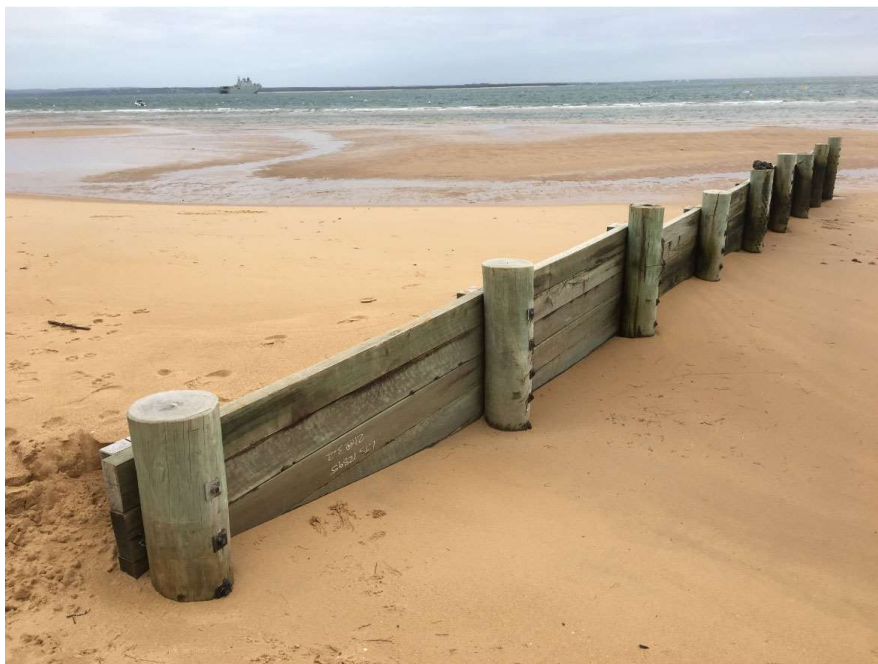
Each of these new timber groynes is built close to the location of a 1947 groyne and the remains of the old groynes were removed. New groynes are approximately 25m long and start just seaward of the rock wall. A typical example is shown in Figure 5-1.

Figure 5-1 Groyne no 13 at Broughton Ave west of Rose Av, built 2018

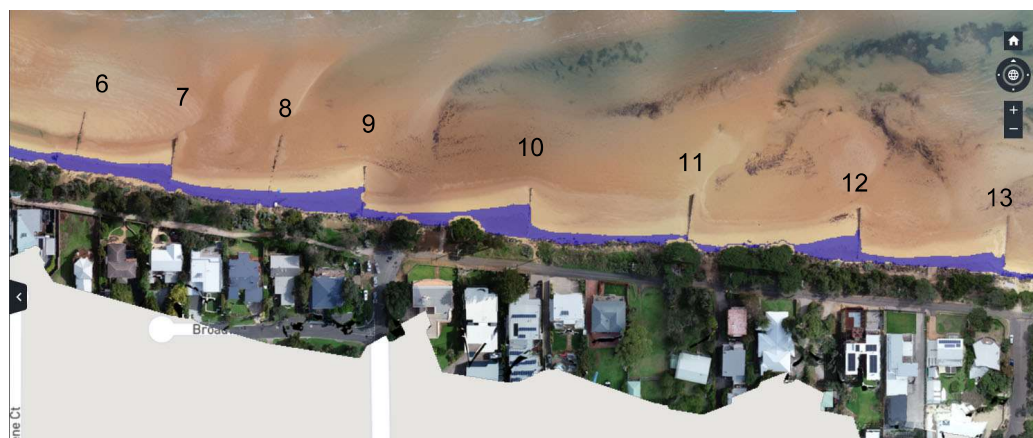
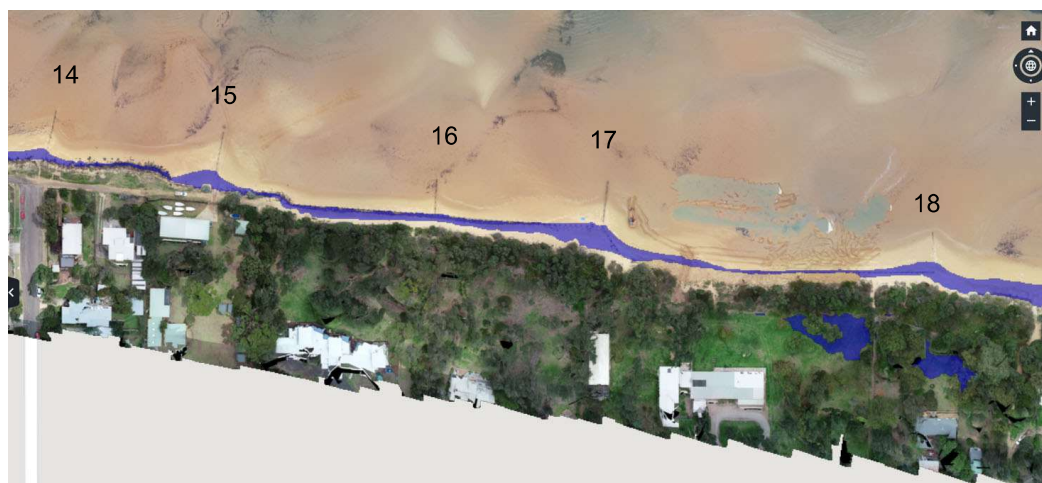
**Figure 5-2 Beach area above high tide (1.2m AHD) 28/2/2020. Data from VCMP**

Figure 5-2 shows (highlighted in purple) the beach area above 1.2m AHD (high tide) for the new groynes around Dunsmore Rd and for the study area between Rose Ave and Coghlan Rd. Asymmetrical beaches have formed in the compartments between the new groynes (number 7, 9, 10, 11, 12, 13), 0 to 5 m wide on the western side of the compartment (eastward of the groynes) and 10 to 15m wide on the eastern side of the compartment (westward of the groynes). In comparison, within the study area (between groynes number 14 to 18) the usable beach above high tide is generally less than 5m wide, noting that much of the purple area shown is actually behind the wooden seawall, which is not ideal for recreation.

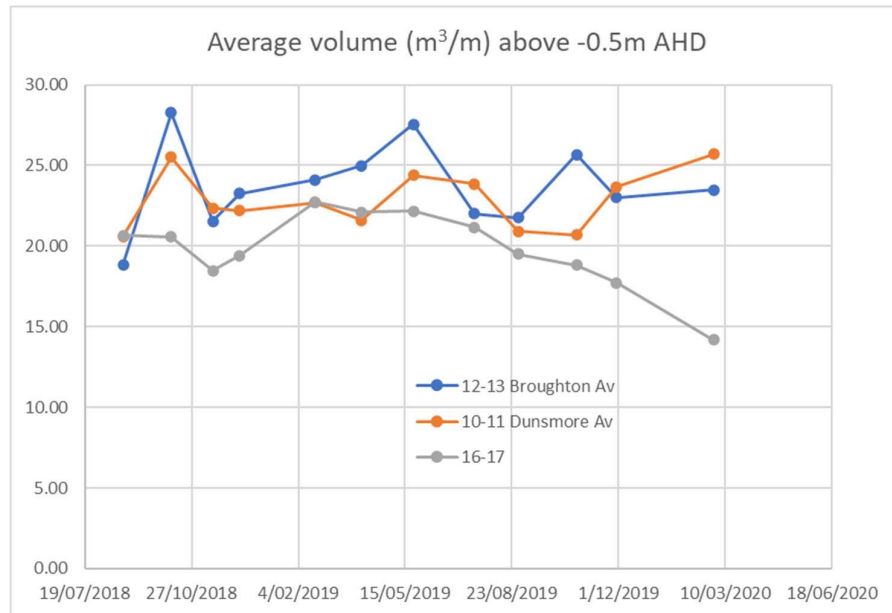
**Figure 5-3 Sand volume in groyne compartments over time. Data from VCMP**

Figure 5-3 shows how the volume of sand in 3 groyne compartments changes over time (for the period of the VCMP data set, August 2018 to February 2020). Compartments 12-13 and 10-11 are between new groynes. In contrast, Compartment 16-17 is between old and not very effective groynes

in the study area. The volume of sand between the new groynes fluctuates but appears to be steady, i.e. no temporal trends are evident; whereas the volume between the old groynes 16 and 17 appears to be on a downward trend. This indicates that the new groynes are being more effective at maintain sand volume on the beach.

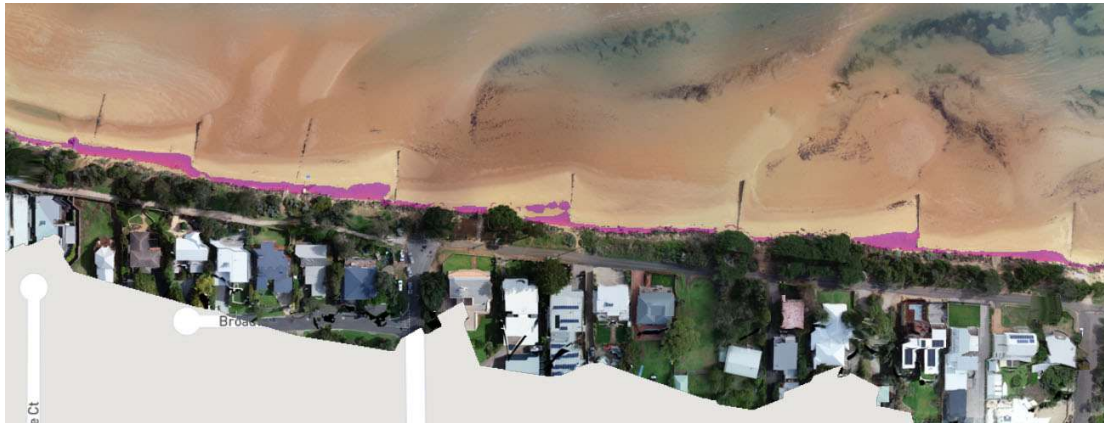
Figure 5-4 Beach area above typical wave runup level (1.6m AHD) 28/2/2020. Data from VCMP

During a moderate erosion event, as has occurred several times already this year, the wave run-up level is estimated as high spring tide (1.1m) plus moderate wave run-up (0.5m) to give a level of 1.6m AHD. Figure 5-4 shows the area of beach above this level (highlighted in pink, in the area of new groynes from Dunsmore Rd to Broughton Ave. The protection offered by the beach is very patchy, in some compartments there is no beach above wave run-up level at all (i.e. the purple area on the map is on top of the rock wall).

**Conclusion:** The beach formed by the new groynes provides only limited protection to the foreshore during minor erosion events. During major erosion events (occurring once or twice per year) the beach is eroded and no protection is provided.

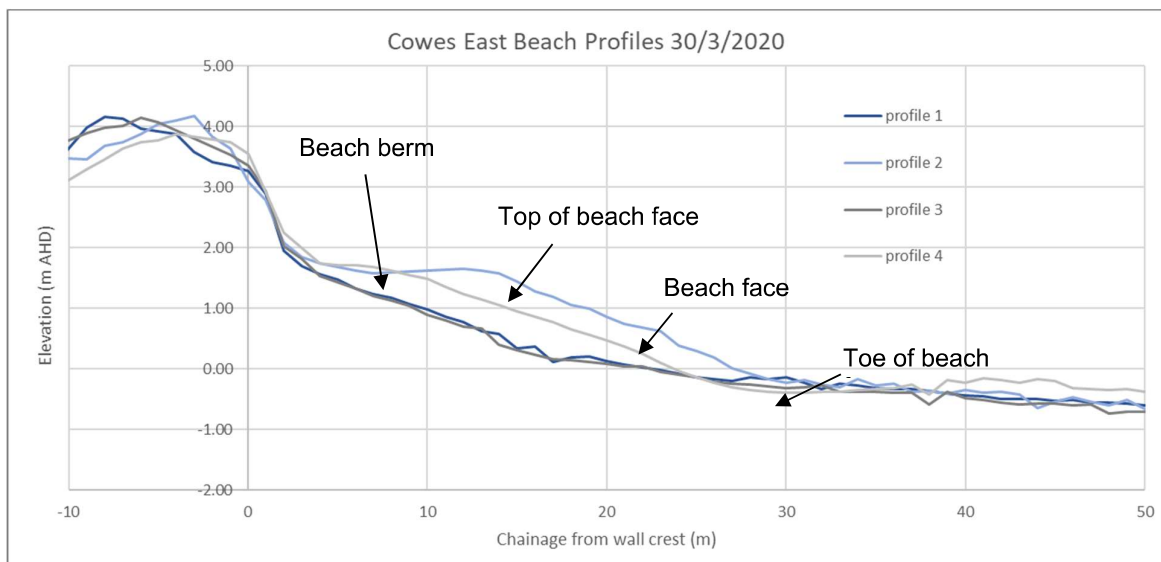
Figure 5-6 Beach profiles in new groyne field

The beach within the groyne compartments has a typical 'full' profile and plan-form that is repeated along the beach, as shown in Figure 5-6 and Figure 5-7. The toe of the beach face is at a level of -0.5 to 0m AHD and the top of the beach face 15-20m further landward is at a level of approximately 1.6m AHD.

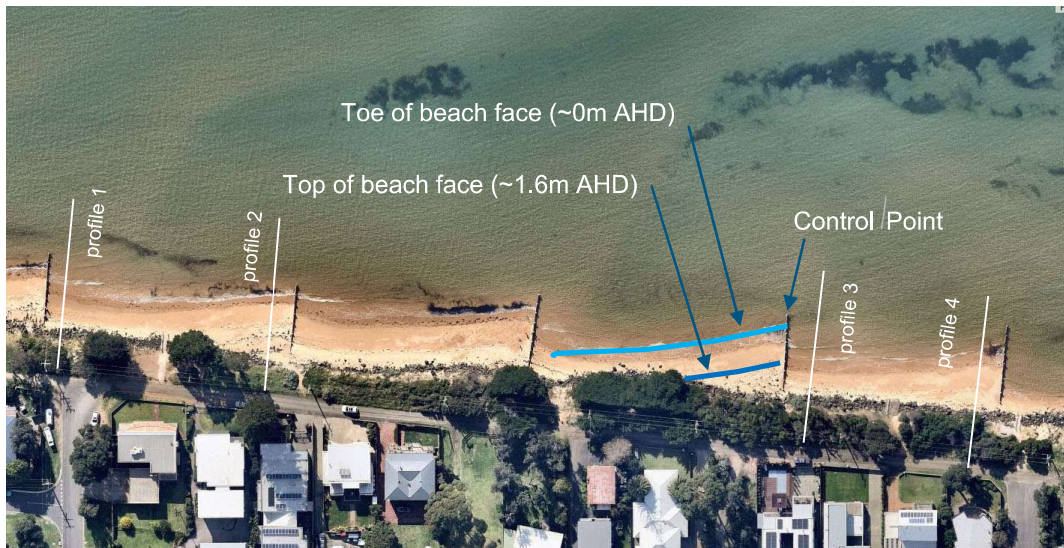
Figure 5-7 Typical beach shape between groynes, Dunsmore Rd to Broughton Ave 31/3/2020

The beach plan-form remains more or less the same (except after erosion events) but the position of the beach face is controlled by the outer end of the groyne on the down-drift (east) side of the compartment (when there is sufficient sediment available to fill the compartment). Hence, the width of the beach can be increased by moving this control point, i.e. either by lengthening the groynes, or decreasing the groyne spacing. To create a 5 to 10m wide beach for the full length of the groyne compartments at Cowes East Beach (noting groynes are 70 to 90m apart) it is estimated that the groynes would need to be extended from 25 to 40m long.

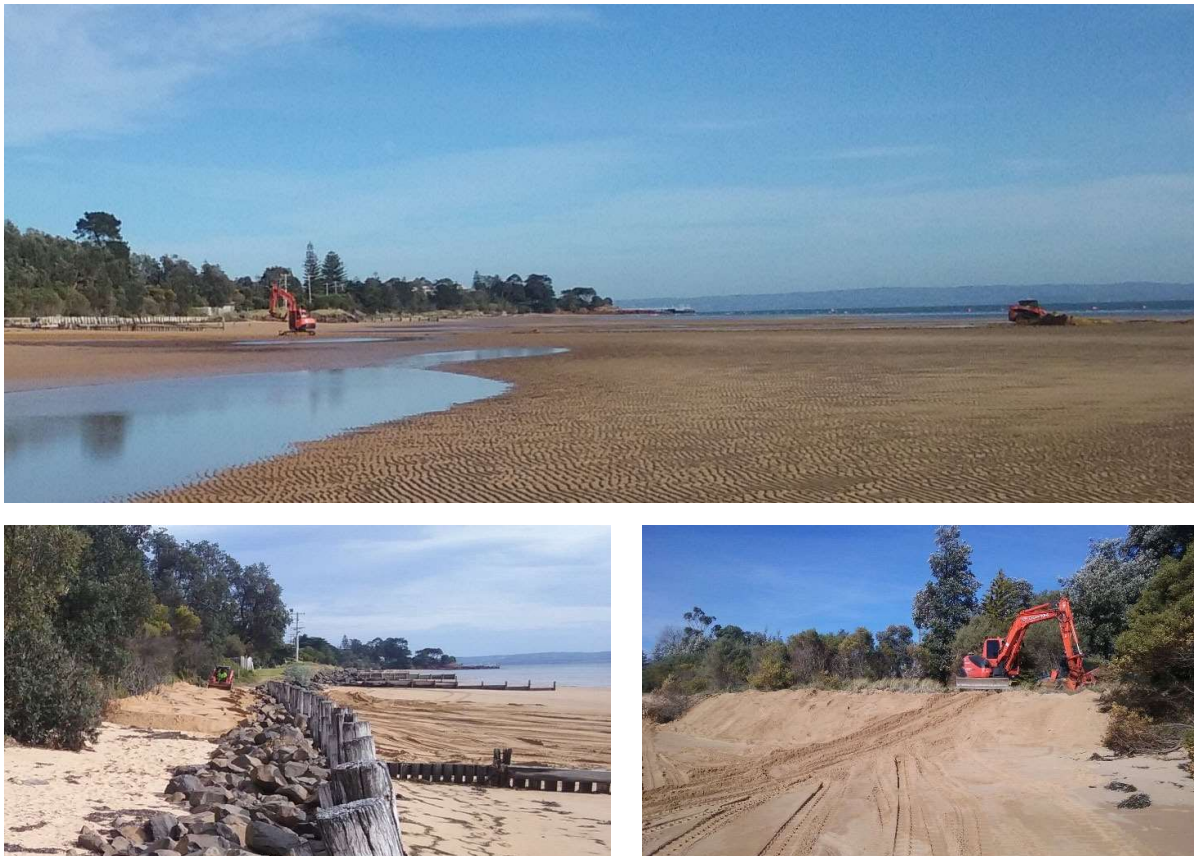
After an erosion event, Council uses a bulldozer and/or excavator to replace sand eroded behind the wall and place a sand buffer in front of the wall, using sand taken from the low tide sand flat of Cowes Bank nearby (Figure 6-1). The sand placed by beach scraping is considered by Council as "sacrificial sand" that provides short-term protection, and there is a requirement for further scraping when the sand is lost to erosion.

**Figure 6-1 Beach Scraping underway after erosion events in 2018 (photos courtesy of BCSC)**
