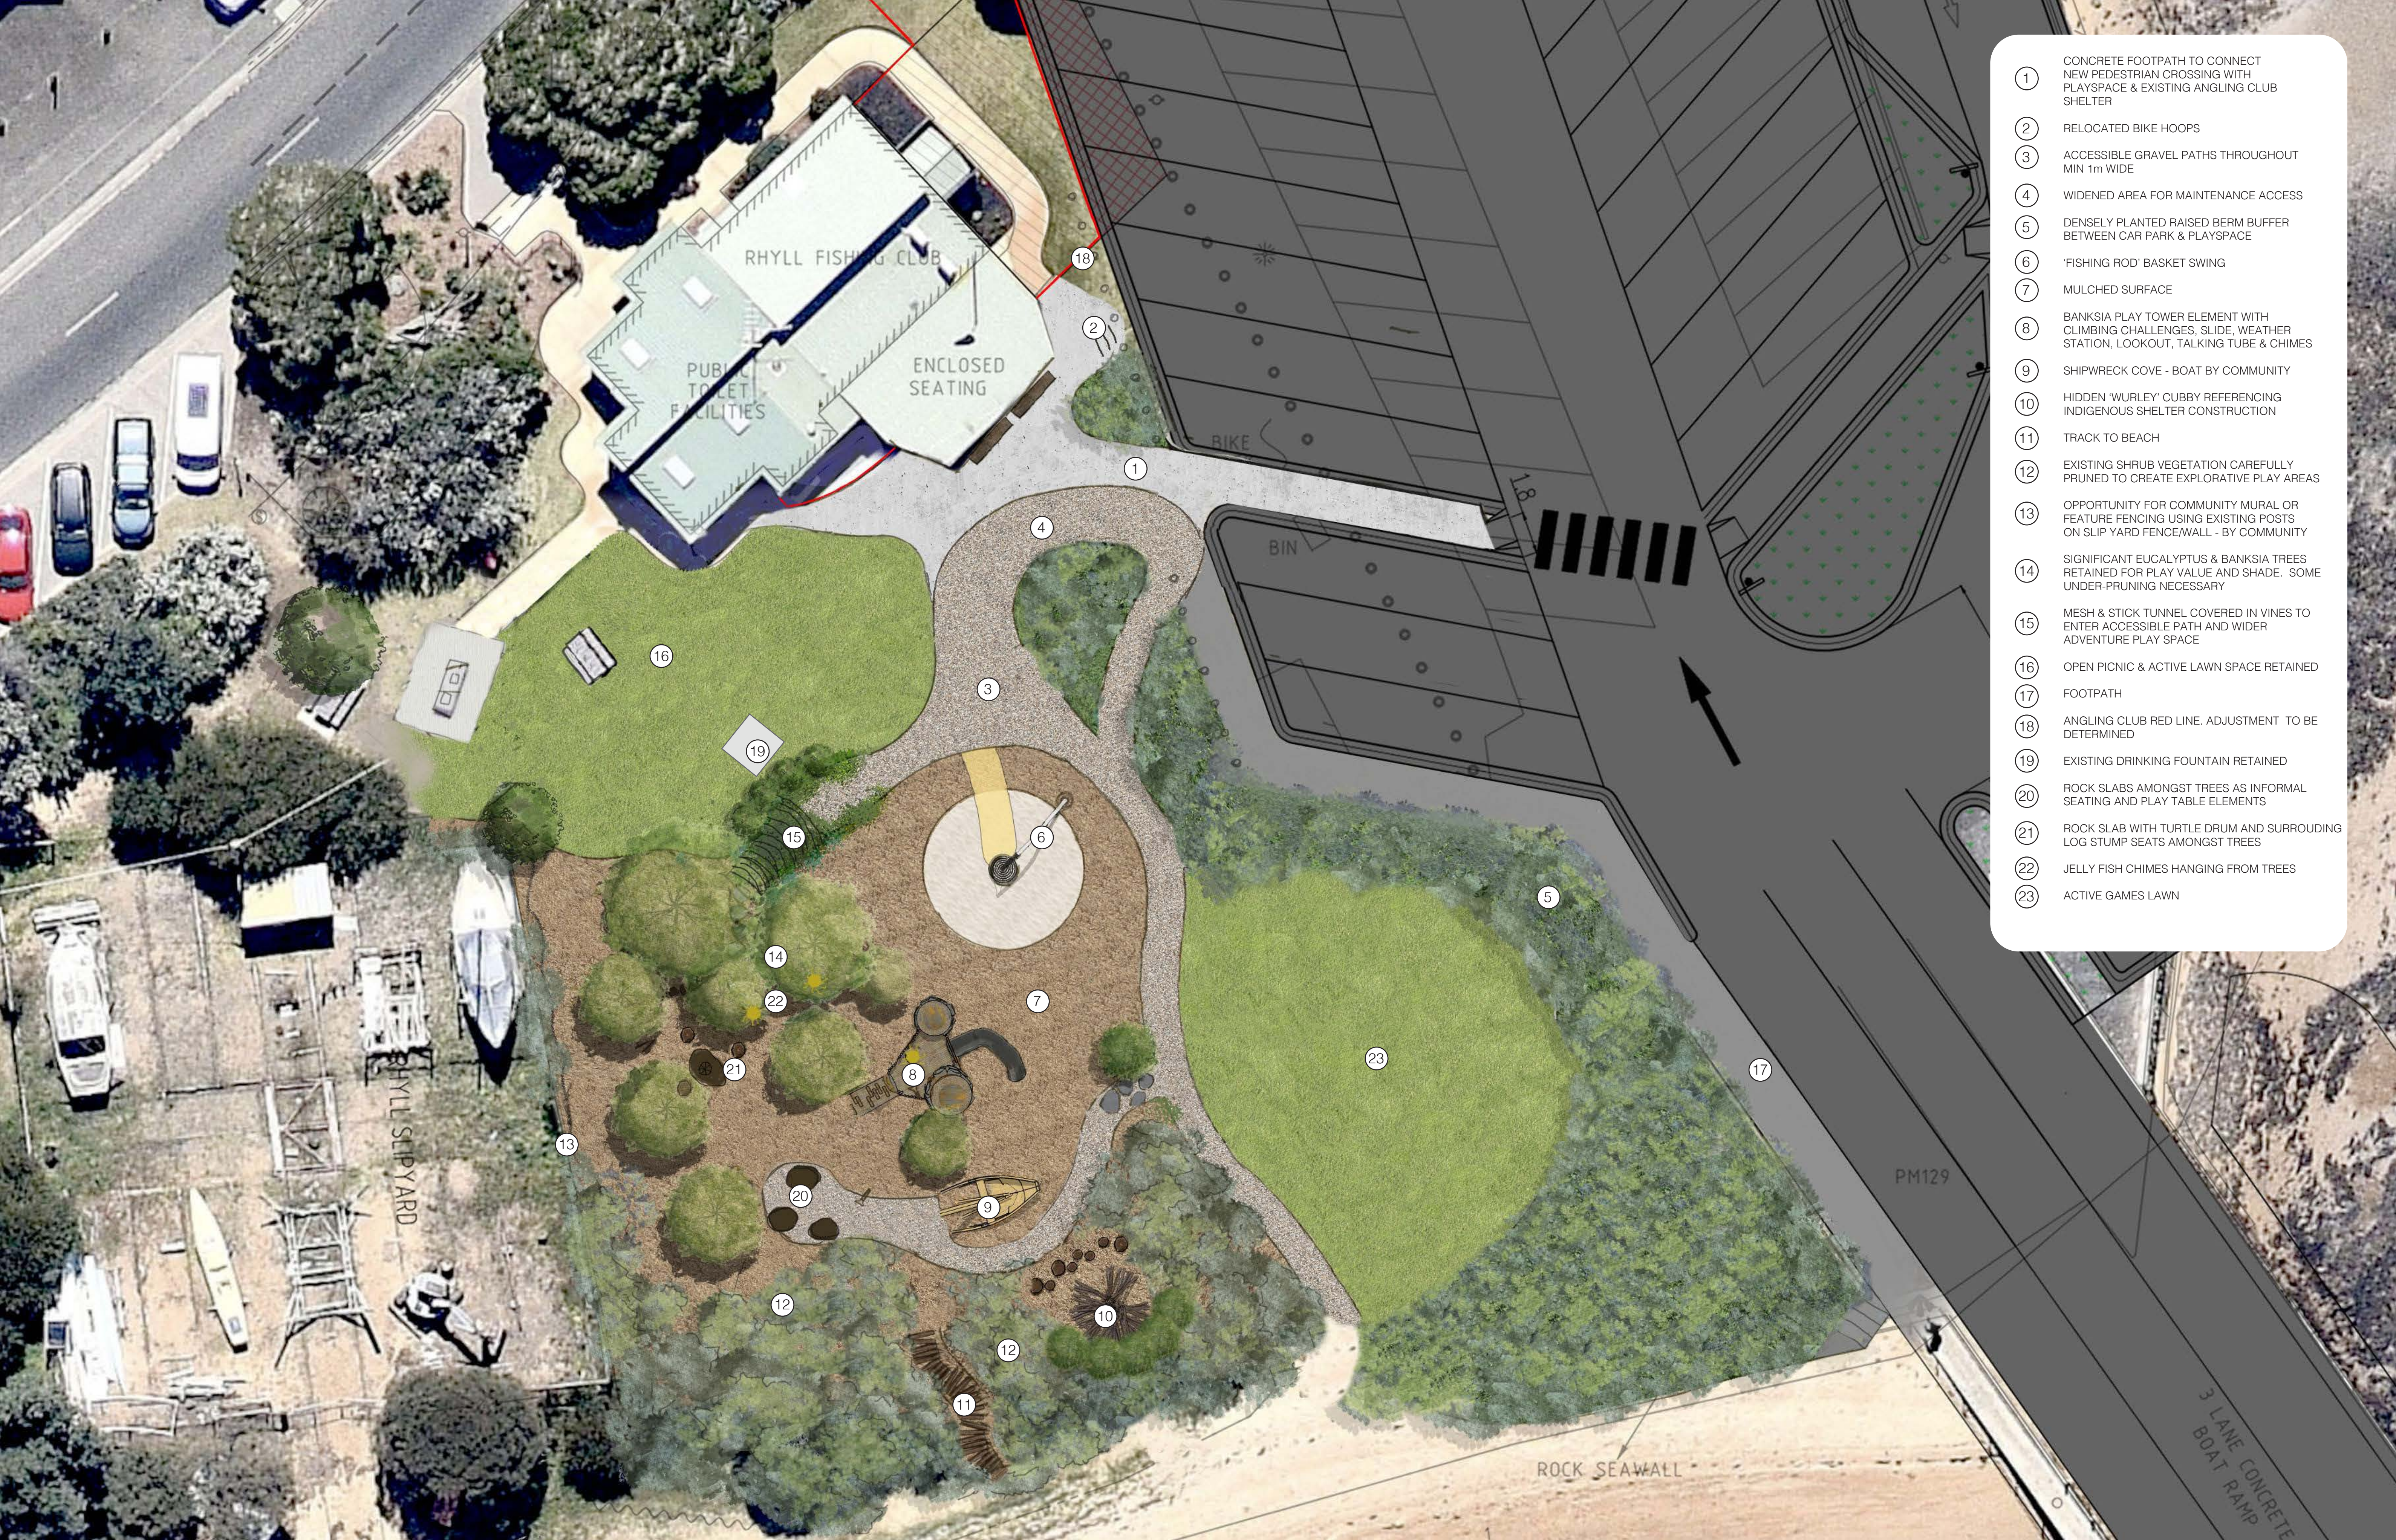
- 1 CONCRETE FOOTPATH TO CONNECT NEW PEDESTRIAN CROSSING WITH PLAYSPACE & EXISTING ANGLING CLUB SHELTER
- 2 RELOCATED BIKE HOOPS
- 3 ACCESSIBLE GRAVEL PATHS THROUGHOUT MIN 1m WIDE

- 4 WIDENED AREA FOR MAINTENANCE ACCESS
- 5 DENSELY PLANTED RAISED BERM BUFFER BETWEEN CAR PARK & PLAYSPACE
- 6 'FISHING ROD' BASKET SWING
- 7 MULCHED SURFACE

- 8 BANKSIA PLAY TOWER ELEMENT WITH CLIMBING CHALLENGES, SLIDE, WEATHER STATION, LOOKOUT, TALKING TUBE & CHIMES
- 9 SHIPWRECK COVE - BOAT BY COMMUNITY
- 10 HIDDEN 'WURLEY' CUBBY REFERENCING INDIGENOUS SHELTER CONSTRUCTION

- 11 TRACK TO BEACH
- 12 EXISTING SHRUB VEGETATION CAREFULLY PRUNED TO CREATE EXPLORATIVE PLAY AREAS
- 13 OPPORTUNITY FOR COMMUNITY MURAL OR FEATURE FENCING USING EXISTING POSTS ON SLIP YARD FENCE/WALL - BY COMMUNITY

- 14 SIGNIFICANT EUCALYPTUS & BANKSIA TREES RETAINED FOR PLAY VALUE AND SHADE. SOME UNDER-PRUNING NECESSARY
- 15 MESH & STICK TUNNEL COVERED IN VINES TO ENTER ACCESSIBLE PATH AND WIDER ADVENTURE PLAY SPACE

- 16 OPEN PICNIC & ACTIVE LAWN SPACE RETAINED
- 17 FOOTPATH
- 18 ANGLING CLUB RED LINE. ADJUSTMENT TO BE DETERMINED
- 19 EXISTING DRINKING FOUNTAIN RETAINED

- 20 ROCK SLABS AMONGST TREES AS INFORMAL SEATING AND PLAY TABLE ELEMENTS
- 21 ROCK SLAB WITH TURTLE DRUM AND SURROUNDING LOG STUMP SEATS AMONGST TREES
- 22 JELLY FISH CHIMES HANGING FROM TREES

- 23 ACTIVE GAMES LAWN
